December Monthly Compliance Report

Solid Waste Permit #498 Bristol Integrated Solid Waste Management Facility 2655 Valley Drive Bristol, VA 24201 (276) 645-7233

02218208.05 | January 10, 2023 Revised January 11, 2023

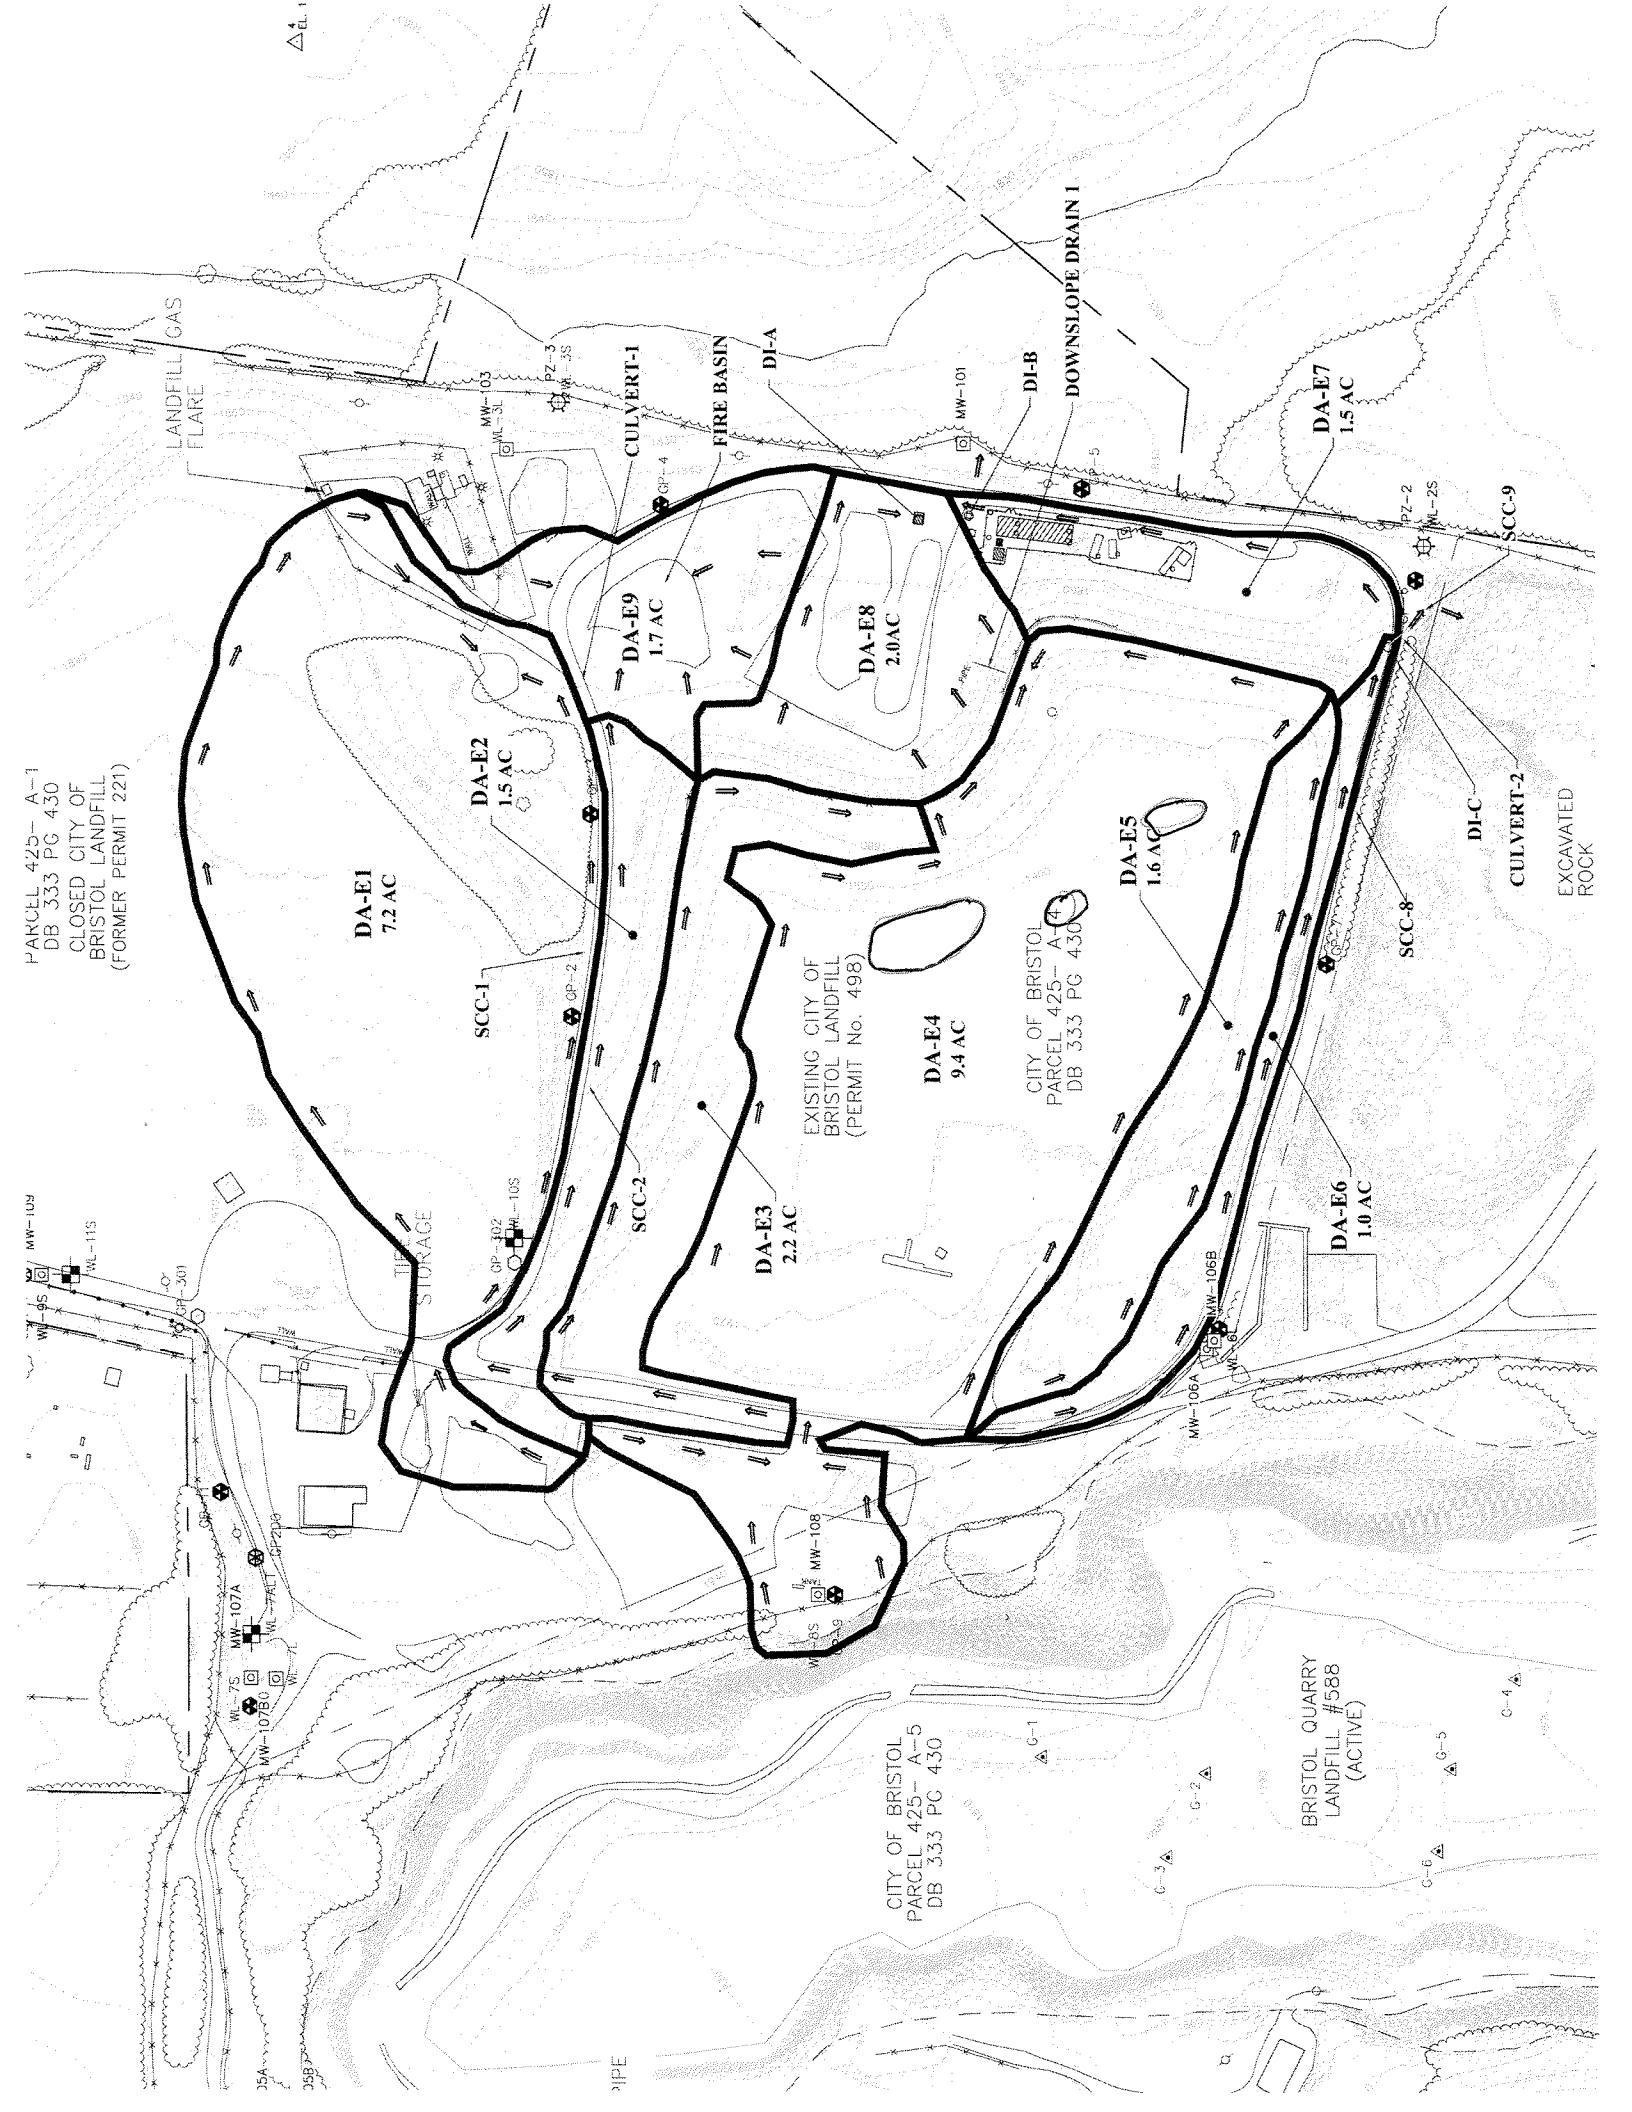
1.	Is there build up or debris that will impede flow to Downslope Drain? If yes, describe:	Yes 🗌	No 📈
2.	Is there standing/ponded water within the SWP 498 boundary?	Yes 🗵	No D OA

3.	Any visible leachate seeps with in SWP 498 boundary?	Yes 🗆	No 🗵
	Describe locations and depth of ponded water or leachate seep (mark locations	in the field	l):

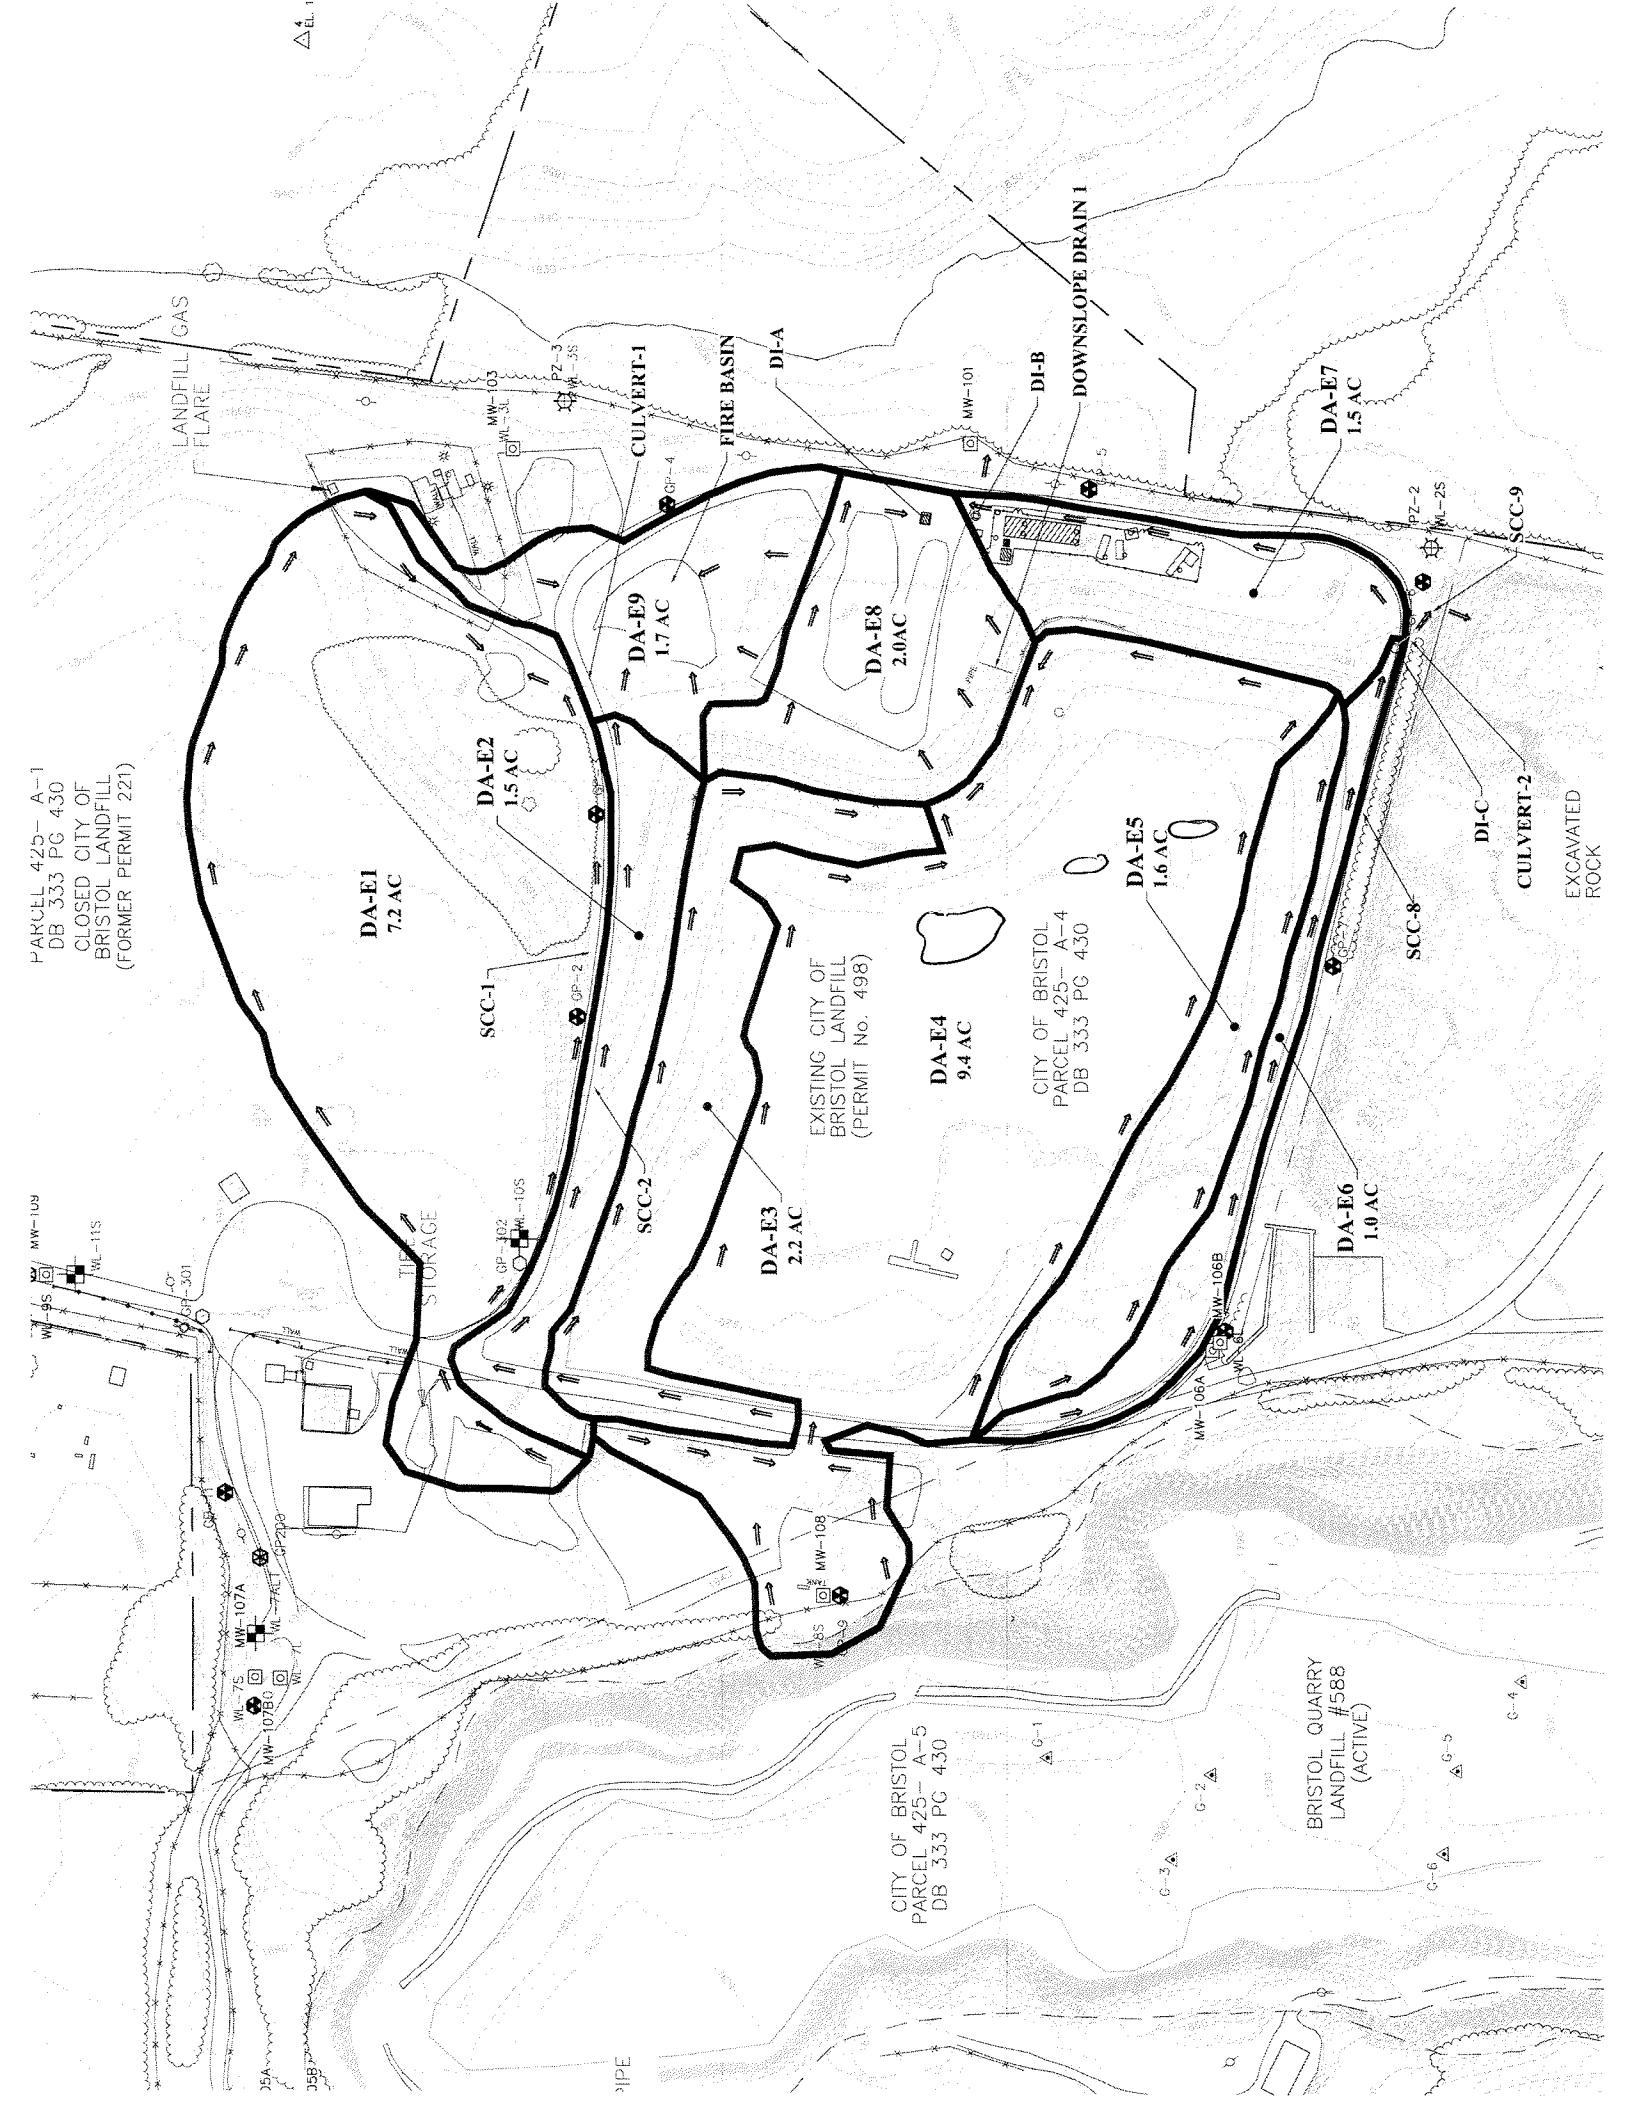
l.	Is there build up or debris that will impede flow to Downslope Drain? If yes, describe:	Yes 🗆	No 🛛
2.	Is there standing/ponded water within the SWP 498 boundary?	Yes 🗷	No 🗆

3.	Any visible leachate seeps with in SWP 498 boundary?	Yes 🗆	No 🗵
	Describe locations and depth of ponded water or leachate seep (mark location	s in the field	d):

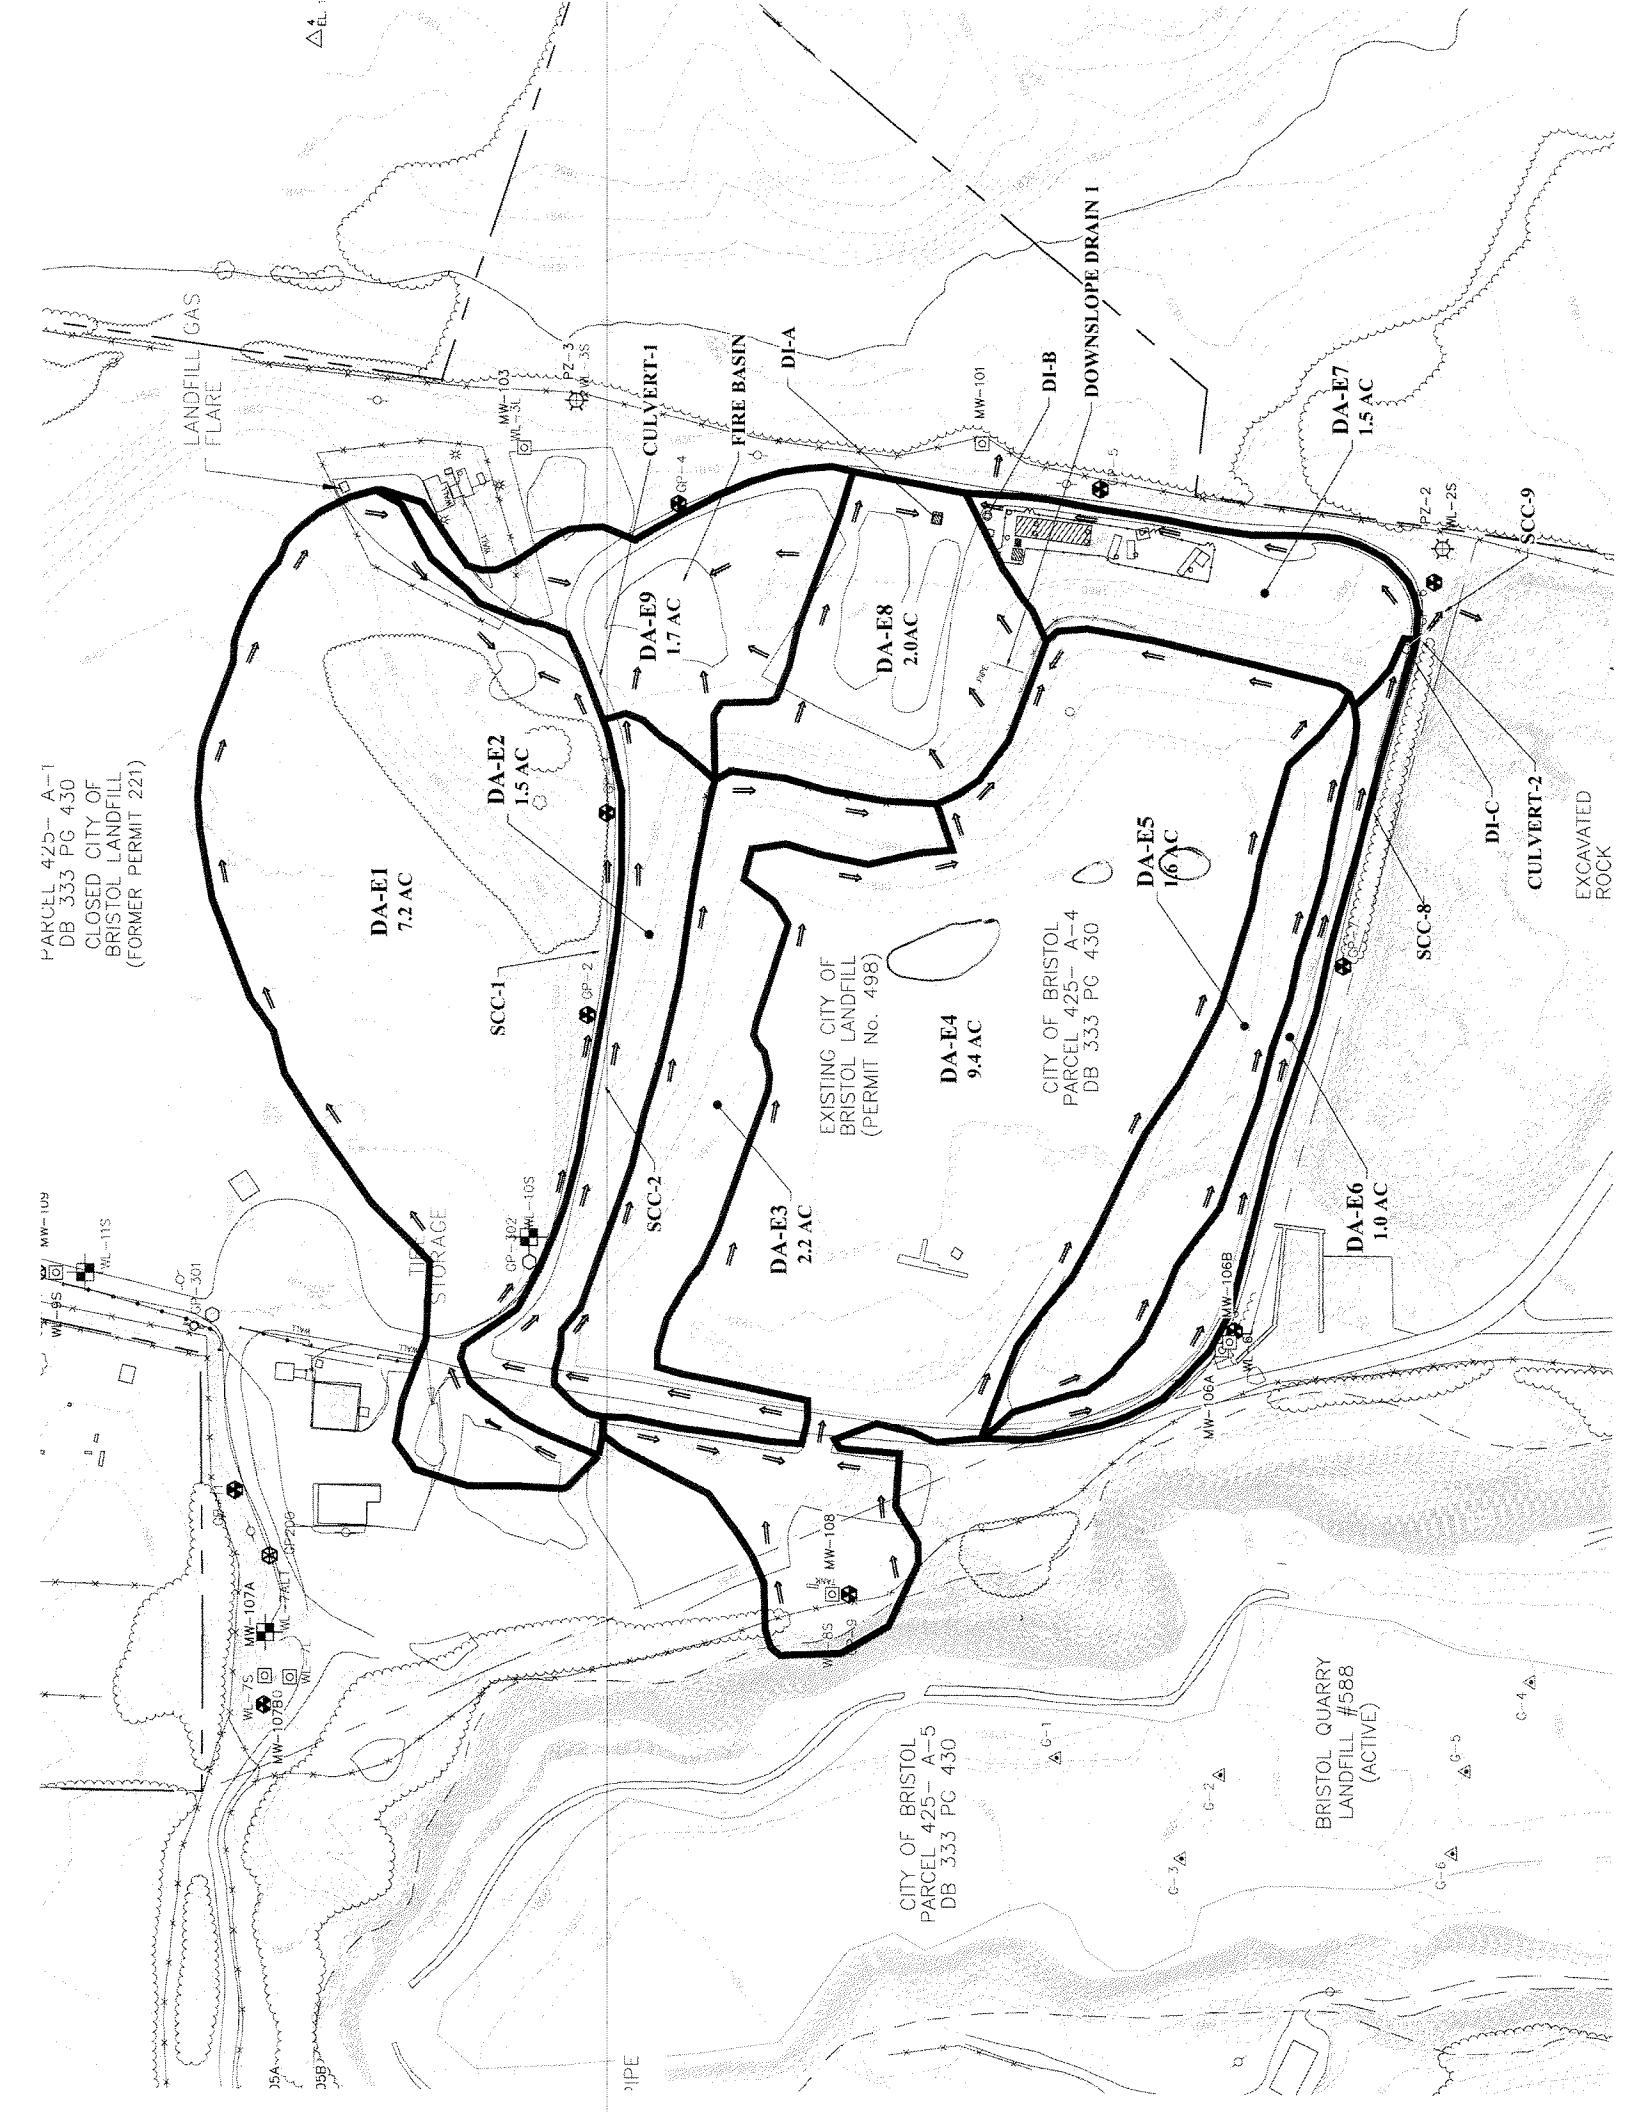
11.	Is there build up or debris that will impede flow to Downslope Dra	uin?	Yes 🗷	No 🗆
	If yes, describe: Vegatative debris on intake.			
12.	Is there standing/ponded water within the SWP 498 boundary?		Yes 🗹	No 🗆

13.	Any visible leachate seeps with in SWP 498 boundary?		Yes 🗆	No 🗵
	Describe locations and depth of ponded water or leachate seep (m	ark locatio	ns in the field	d):
	Ponding shown on map. ~ 4-6 in ches	deep.

14.	Describe any intended remediation actions: Fine grading for	r final	cap insta	llatim
	will amove low spots. Debis removed frem	Down	Slage Prais	a ntake.
