March Monthly Compliance Report

Solid Waste Permit #498
Bristol Integrated Solid Waste Management Facility
2655 Valley Drive
Bristol, VA 24201
(276) 645-7233

SCS ENGINEERS

02218208.05-18 | April 10, 2023

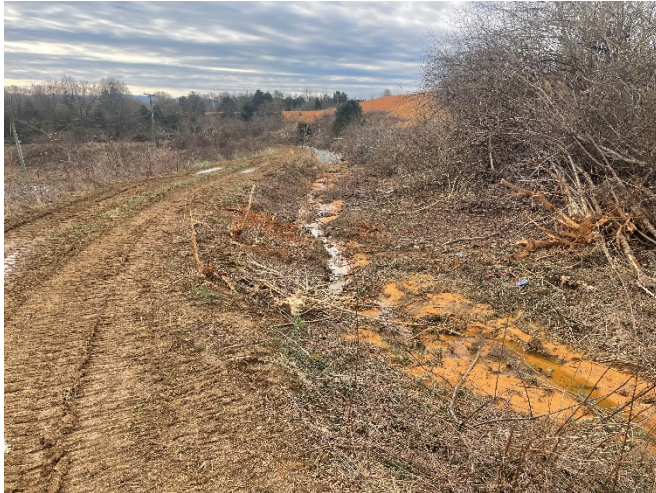
Stormwater diversion channel and trench berm prior to clean-out and stabilization.

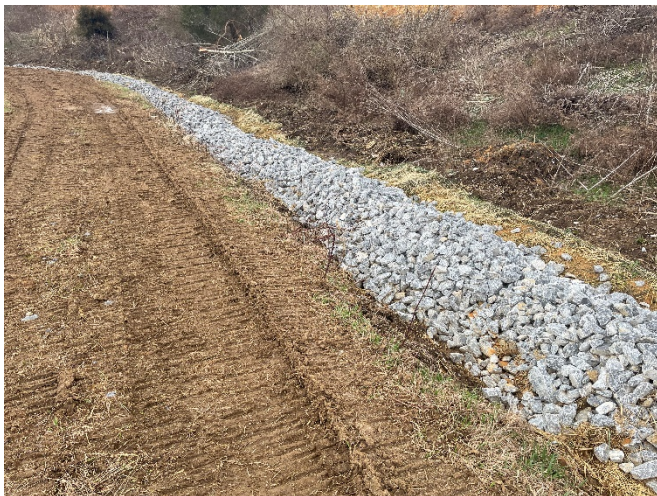
Stormwater diversion channel and trench berm with sediment removed, erosion control matting in place, and aggregate placed.

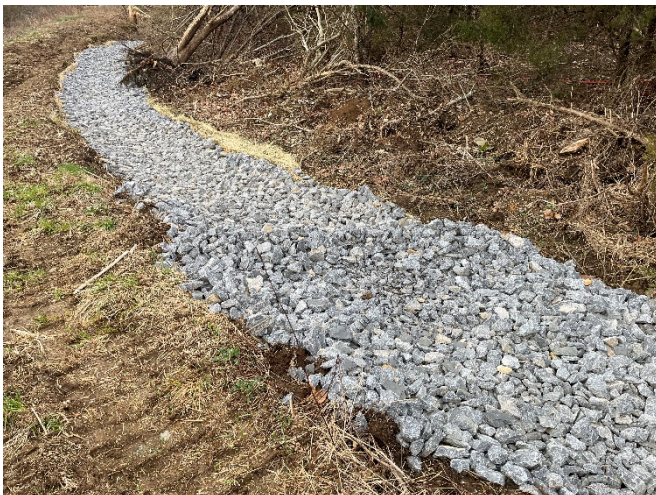
Stormwater diversion channel and trench berm with sediment removed, erosion control matting in place, and aggregate placed & spread.

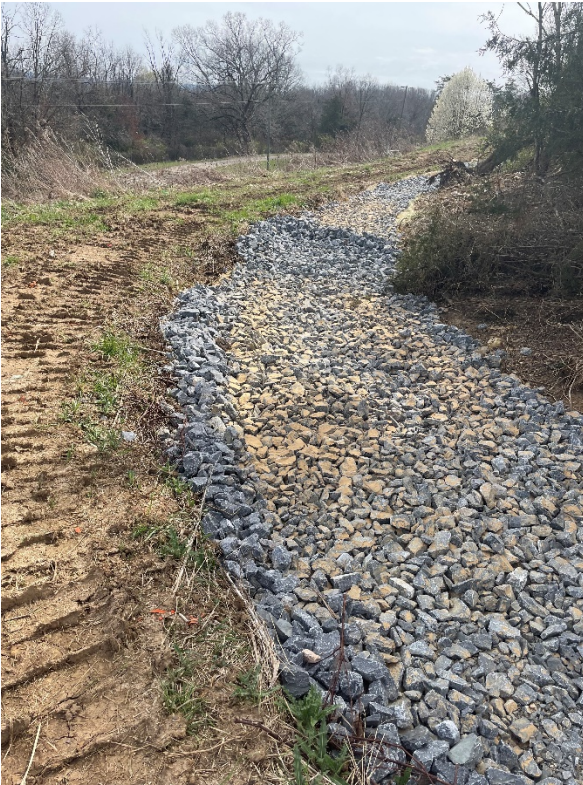
Stormwater diversion channel and trench berm with sediment removed, erosion control matting in place, and aggregate placed & spread.

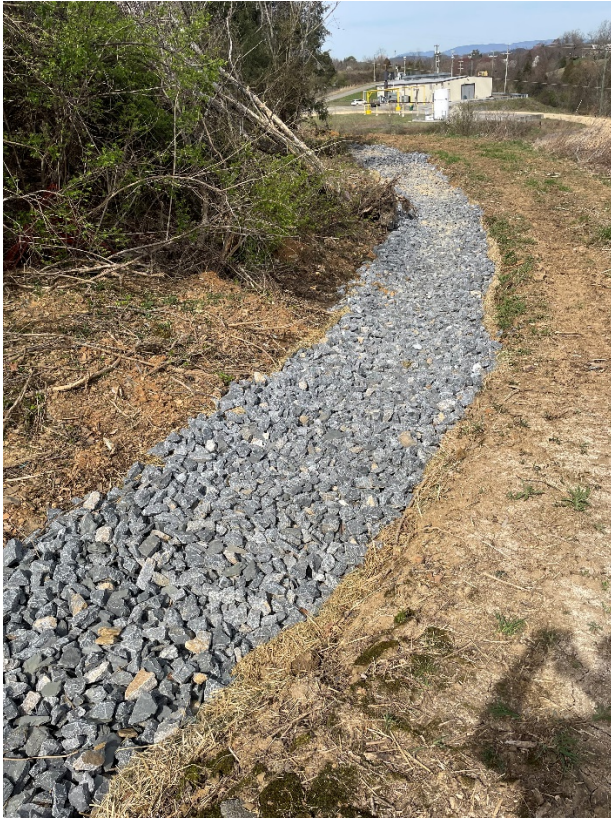
Stormwater diversion channel and trench berm with sediment removed, erosion control matting in place, and aggregate placed & spread.
