# February 2024 Monthly Compliance Report

Solid Waste Permit No. 498  
Bristol Integrated Solid Waste Management Facility  
2655 Valley Drive  
Bristol, VA 24201  
(276) 645-7233

02218208.05-30 | March 8, 2024

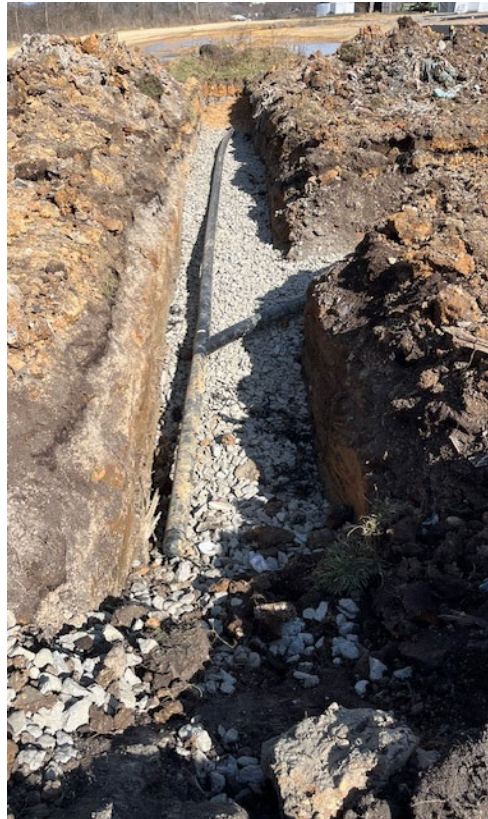
Figure 1. Construction of a Horizontal Collector and EW-16

During the month of February, EW-16 was modified to add a horizontal collector to the vertical extraction well. A trench was excavated adjacent to the existing EW-16. A perforated pipe was placed in the trench and connected to the existing EW-16. The trench was backfilled with aggregate and a geotextile was placed over the aggregate before the horizontal collector was covered with soil. Construction of the horizontal collector is shown in Figure 1. This horizontal collector was added to improve the effectiveness of EW-16 and reduce the percentage of methane in measurements of gas composition at GP-200.

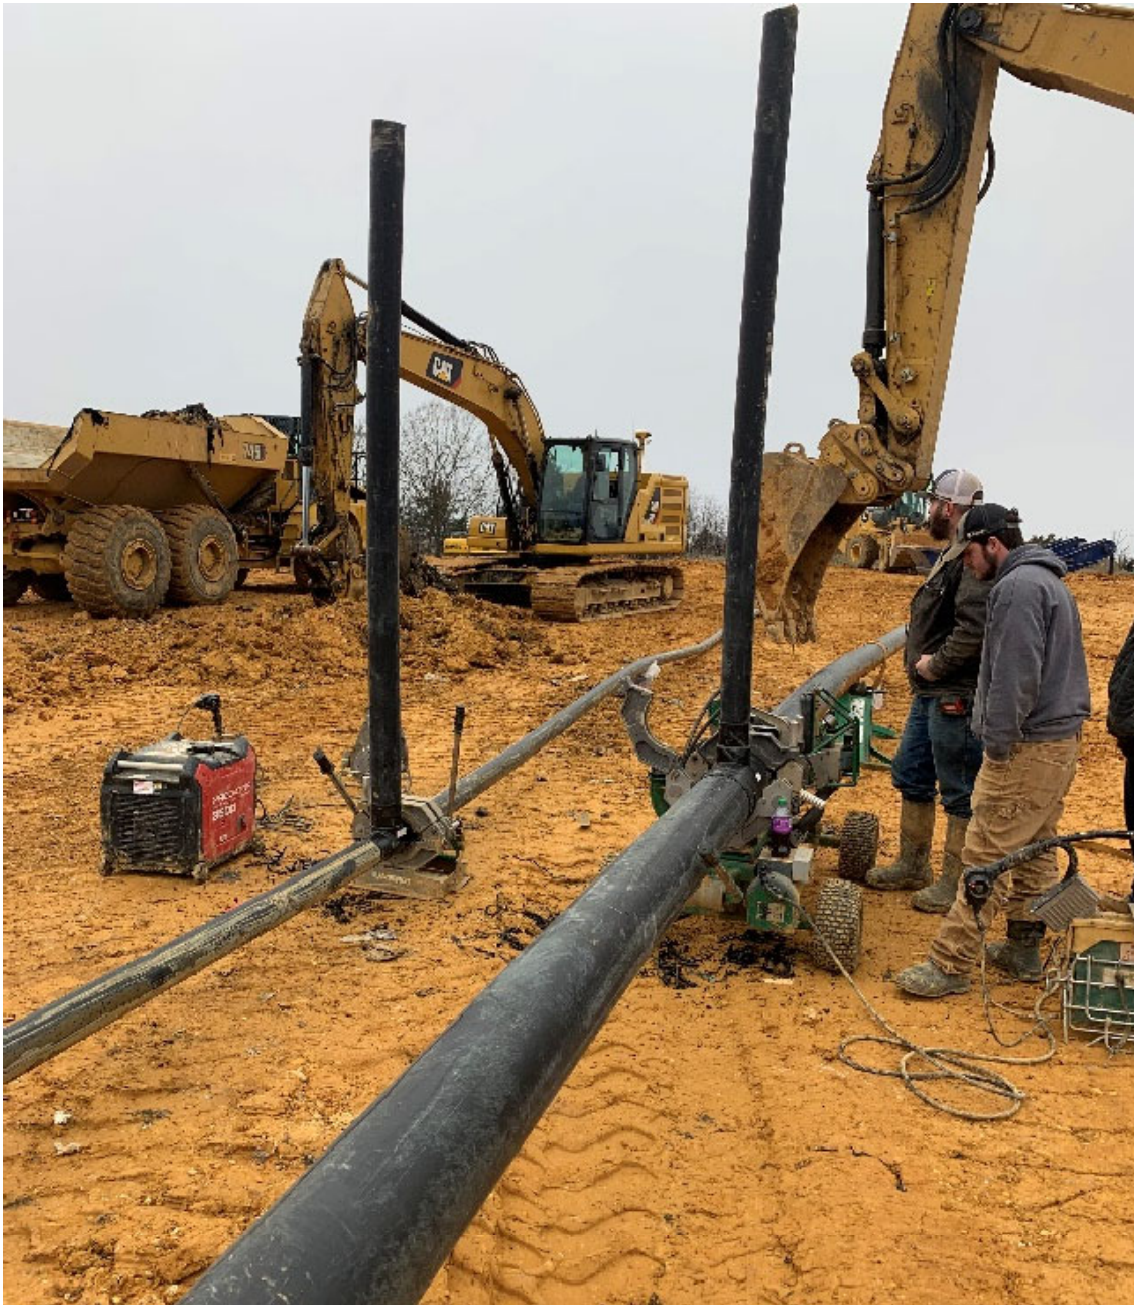
Figure 2. Landfill Gas Installation Progress - SWP No. 498 Landfill

Construction progress during February included installing landfill gas horizontal collectors, 8" and 6" headers, airline, and force main. Figures 2 and 3 show the fusing of the landfill gas pipes (left) and the connection of the landfill gas headers to the new condensate sump (right). The lateral connections to the new soil extraction wells (drilled during January) were also installed along with new landfill gas drainage pits and horizontal collector wellheads (see Figure 4).

The City and Baker's Construction Services, Inc. (BCS) signed the construction contract and the notice to proceed was issued on October 17, 2023. BCS mobilized to the site in late October and construction is currently ongoing. Construction so far has included the installation of erosion and sediment control measures, ongoing earthwork to establish the geomembrane deployment grade, excavation of the expanded stormwater basin, installation of the stormwater sewer system, and the ongoing installation of the new landfill gas system. SCS CQA personnel are mobilized to the site to monitor BCS's progress.

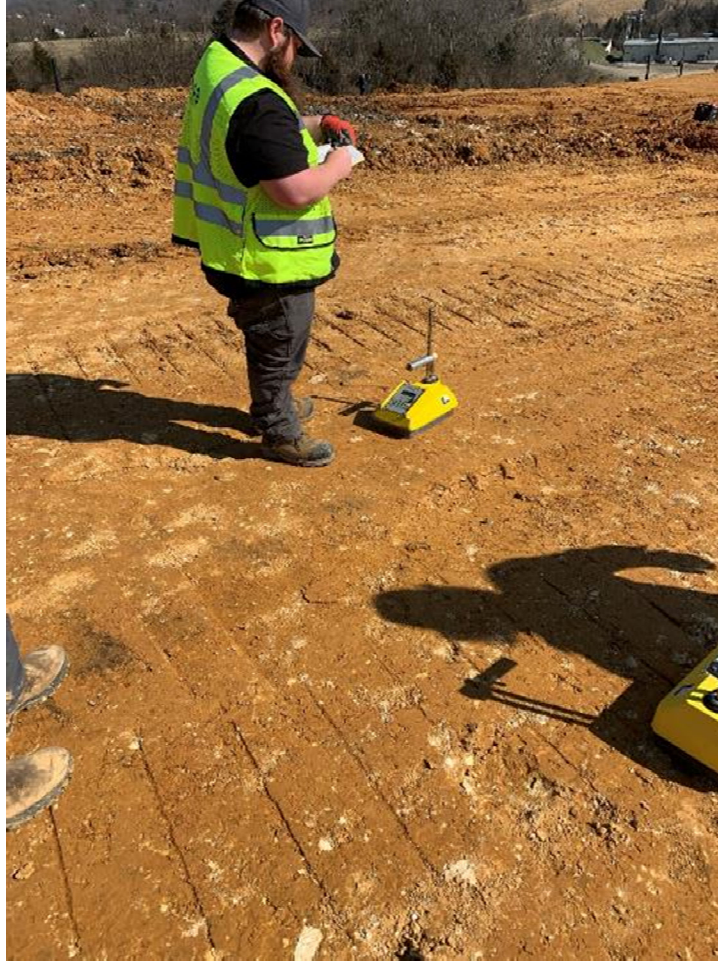
Figure 5. Soil Density testing

Installation of intermediate cover soil continued along the west side of the final cover area. Density and depth testing continued as the soil installation progressed (see Figure 5). BCS continued to develop the new borrow area for installation of the remaining intermediate cover soil and upcoming erosion control layer.

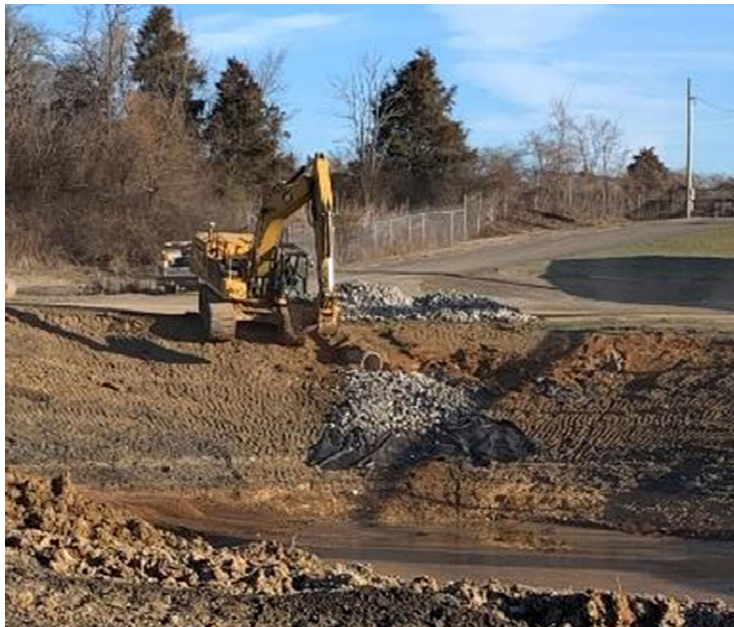
Figure 6. Installation of Outlet Protection in the Stormwater Basin

Stormwater construction progress during February included installing covers for the stormwater drop inlets and stabilizing the stormwater basin area. Outlet protection was installed for the stormwater pipes discharging into the basin.

The existing stormwater pond positioned near the northeast corner of the landfill has been expanded to provide additional storage volume, and a new stormwater outlet structure has been installed. The stormwater pond will discharge via the existing 42-in reinforced concrete pipe (outfall SW-1). Stormwater modeling included with the permit modification documents demonstrates compliance with channel and flood protection criteria.
