EVOH Deployment Suitability
Assessment No. 1
Bristol Integrated Solid Waste Management
Facility
Solid Waste Permit No. 588

SCS ENGINEERS

02218208.05 | April 11, 2024

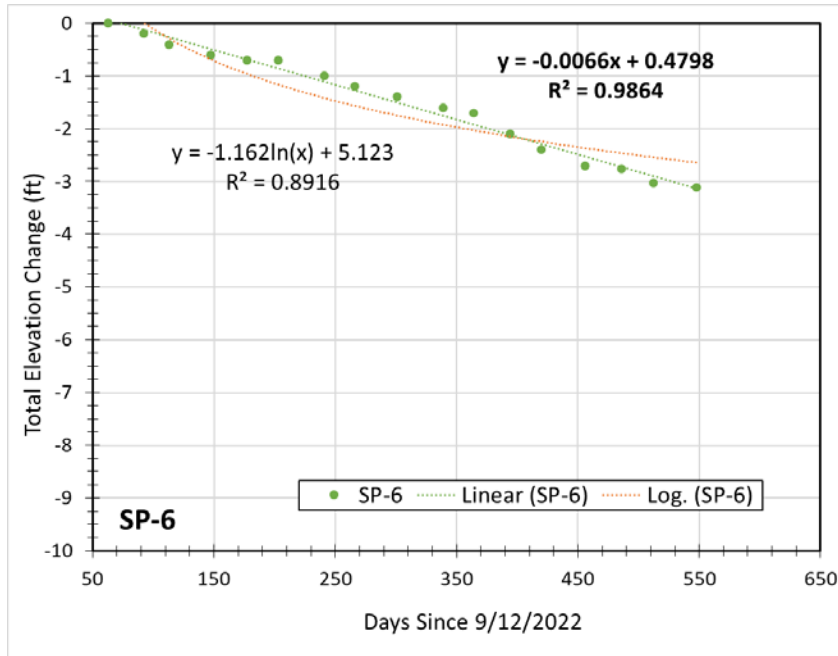
Figure 5 - Settlement Plate 6

The data for settlement plates 6 and 8 fit linear trendlines (Figure 5 and Figure 6). The elevated temperatures measured by TP-4, 100 feet east of SP-6, suggests that SP-6 will continue to settle significantly. SP-8 is positioned north of the highest temperature area and may stabilize prior to the southern settlement plates. The logarithmic trendline for SP-8 gives an R^2 of 0.96 versus 0.99 for the linear trendline. SP-7 was excluded from the analysis due to suspected damage, and SP-9 was excluded due to unavailable data.

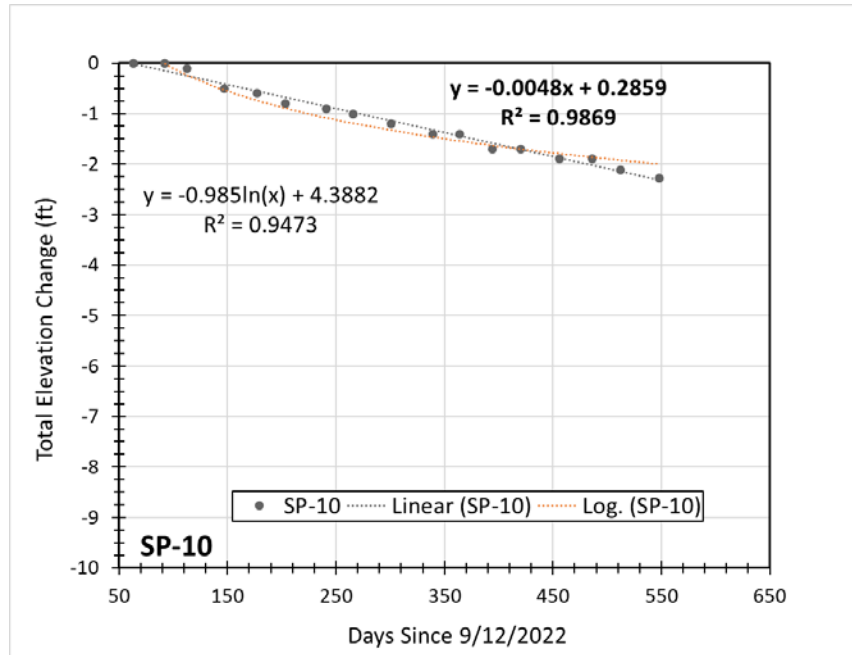
Figure 7 - Settlement Plate 10

SP-10, SP-11, and SP-12 are positioned in the north end of the quarry. The northernmost temperature probe (TP-9) indicates lower, more stable temperatures in this area relative to the south. The elevation data from these settlement plates shows less overall settlement and lower strain rates (less than 1% per year) relative to the southern plates (Figure 7 through Figure 9). The temperature and elevation data together suggest the northern area may be transitioning to secondary compression, but settlement remains linear with respect to time. Elevation variability,

potentially due to vertical accuracy limitations of the GPS measurements, appears more noticeable for these settlement plates due to the smaller settlement rates.

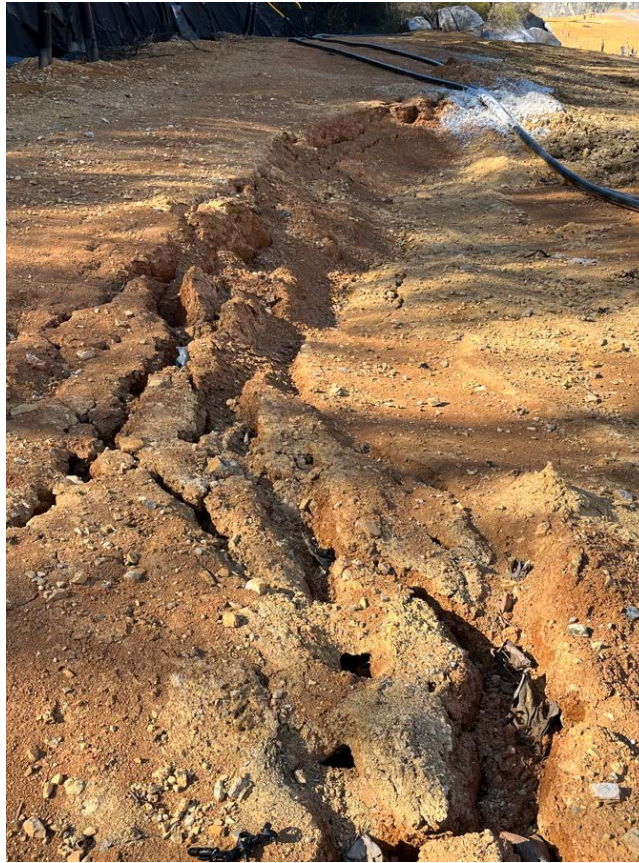
Figure 10 - Scarp and Settlement Cracks

Personnel working in the quarry continue to observe surface cracks due to settlement exceeding 1-inch width. Settlement cracks and a scarp were observed during March in the southern region of the quarry between settlement plates SP-1 and SP-4, approximately 20 to 40 feet from the sidewall. The cracks and scarp extended along a linear region, approximately 100 feet long, which follows an abrupt change in the base grade elevations and corresponding waste thickness.

Figure 10 shows a photo of the settlement cracks and scarp, facing northwards. Settlement cracks measuring approximately 2 to 4 inches are visible in the foreground. The scarp, visible in the background, measures approximately 3 feet. Figure 11 shows the same scarp, facing westwards.

The observed surface cracks and scarp indicate that criteria 3 is not satisfied.

The scarp is located above the edge of a bench in the rock wall created by quarry operations. The bench remained in place when the facility was converted to a landfill. SCS estimates that the waste thickness transitions from approximately 10 feet to 136 feet over a horizontal distance of 42 feet. If waste at both thicknesses settles at a similar, nonzero strain rate, it creates a differential in elevations. SCS believes that this differential waste thickness is the cause of these cracks at the surface.
