# March 2024 Monthly Compliance Report

Solid Waste Permit No. 498  
Bristol Integrated Solid Waste Management Facility  
2655 Valley Drive  
Bristol, VA 24201  
(276) 645-7233

02218208.05-30 | April 10, 2024

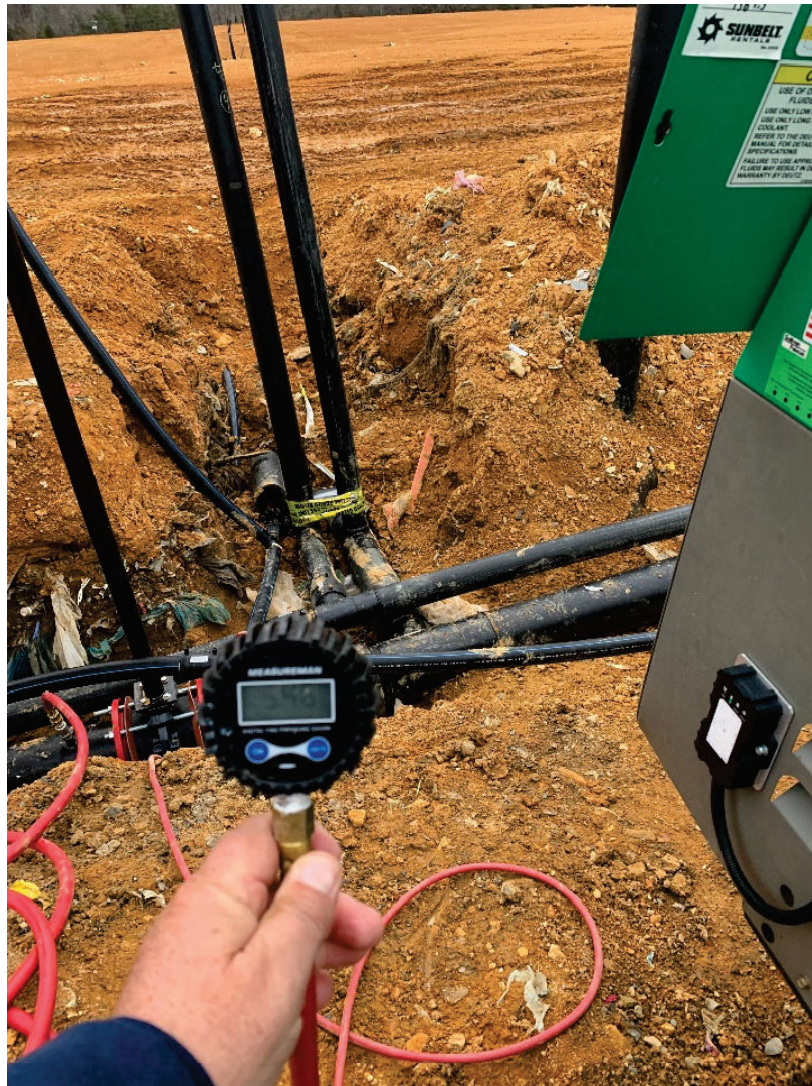
Figure 1. Landfill Gas Pressure Testing - SWP No. 498 Landfill

Landfill gas construction progress during March included installing the air and force main tie-ins, installing road crossings, abandonment of EW-22, and pressure testing. Figures 2 and 3 show the pressure testing of landfill gas pipe and the installation of a road crossing for the landfill gas header. New air and force main lines were tied into the existing lines located west of the landfill, and isolation valves were installed (see Figure 4).

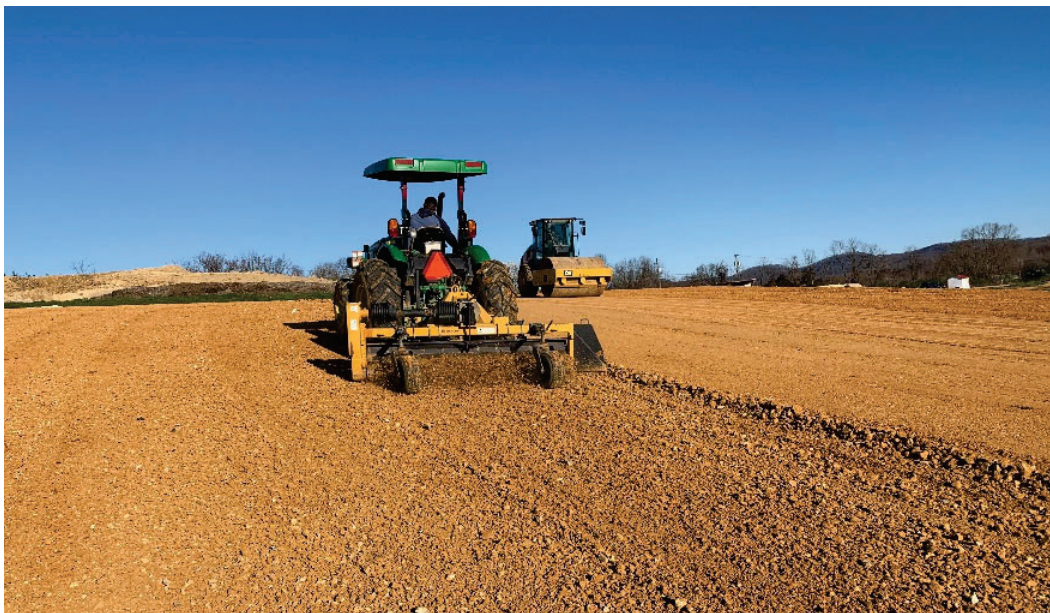
Figure 4. Mechanical Raking of the Intermediate Cover Soil Surface

Installation of intermediate cover soil continued along the west side of the final cover area during early and mid-March. Density and depth testing continued as the soil installation progressed. During this same period, as the target grade was reached, BCS prepared for geomembrane deployment by hand picking and mechanical raking of the cover soil surface to remove rocks and debris (see Figure 5). The surface was smooth-drum rolled prior to installing the geomembrane.

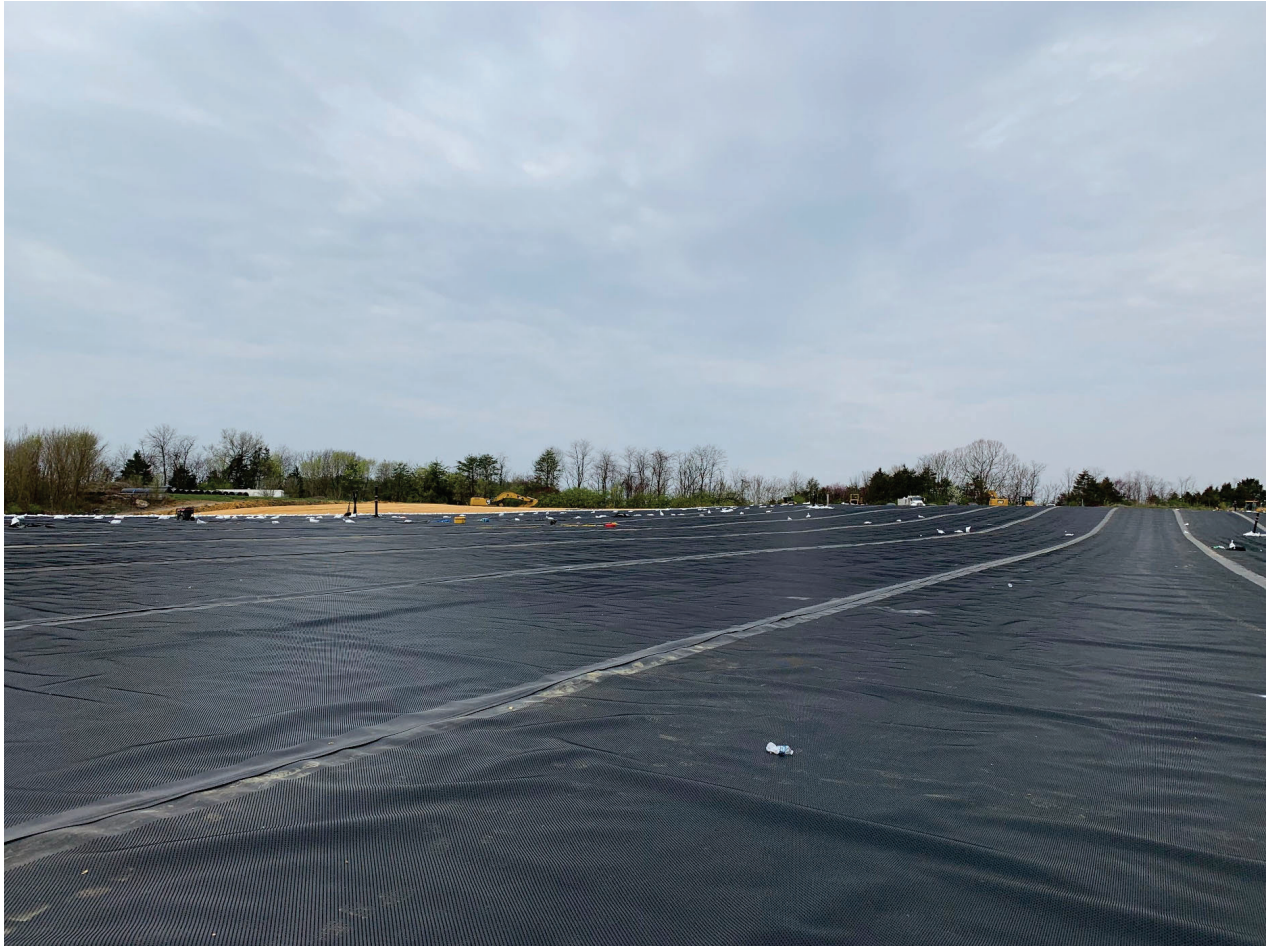
Figure 5. Geomembrane Installation on March 22<sup>nd</sup>

Hallaton Environmental Linings (Hallaton) commenced geomembrane deployment on March 20, 2024. The first rolls were placed in an east-west orientation, starting on the west side of the landfill (see Figure 6). SCS is observing and documenting the geomembrane installation, and quality assurance efforts include logging welding progress, panel placement, repair locations, air pressure testing (Figure 7), and destructive sample locations. SCS is using field GPS equipment to prepare the as-built geomembrane layout.

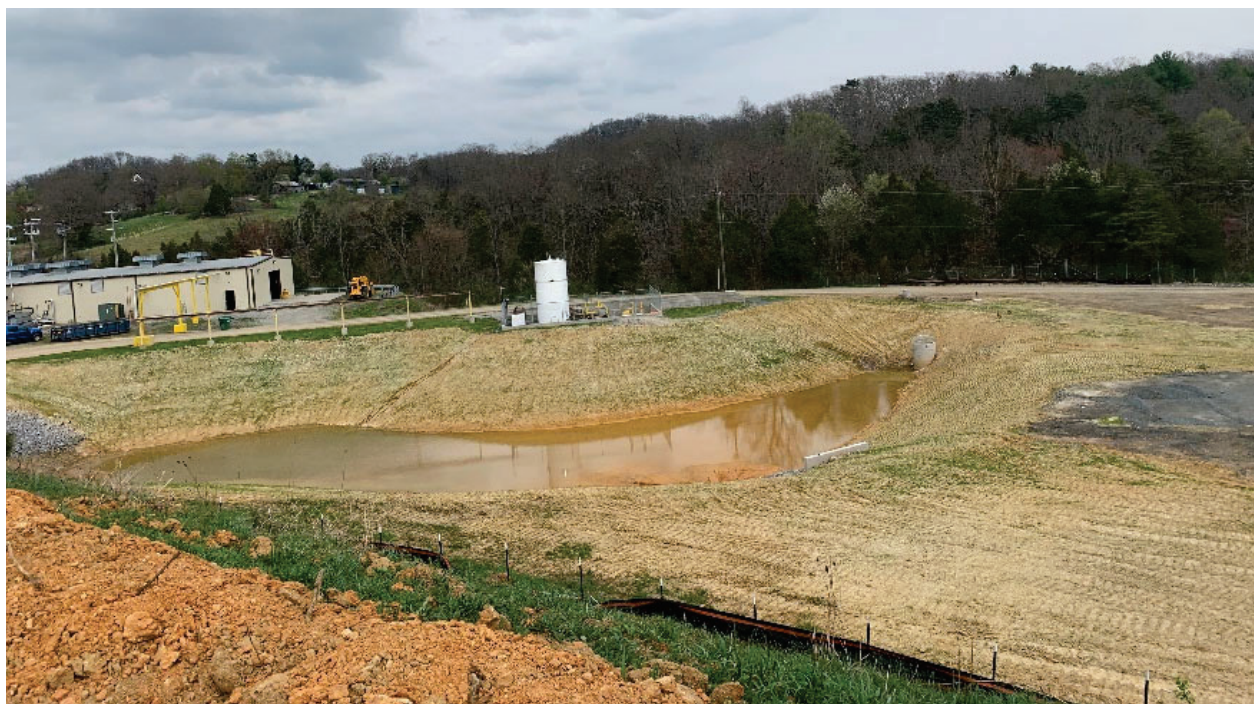
Figure 7. Stormwater Basin Status

Stabilization of the stormwater basin area was started in February and is ongoing. Vegetation growth is expected continue during the spring of 2024. Figure 7 shows the conditions of the stormwater pond during the month of March 2024.
