January 2025 Monthly Compliance Report

Solid Waste Permit No. 588
Bristol Integrated Solid Waste Management Facility
2655 Valley Drive
Bristol, VA 24201
(276) 645-7233

02218208.05-37 | February 10, 2025

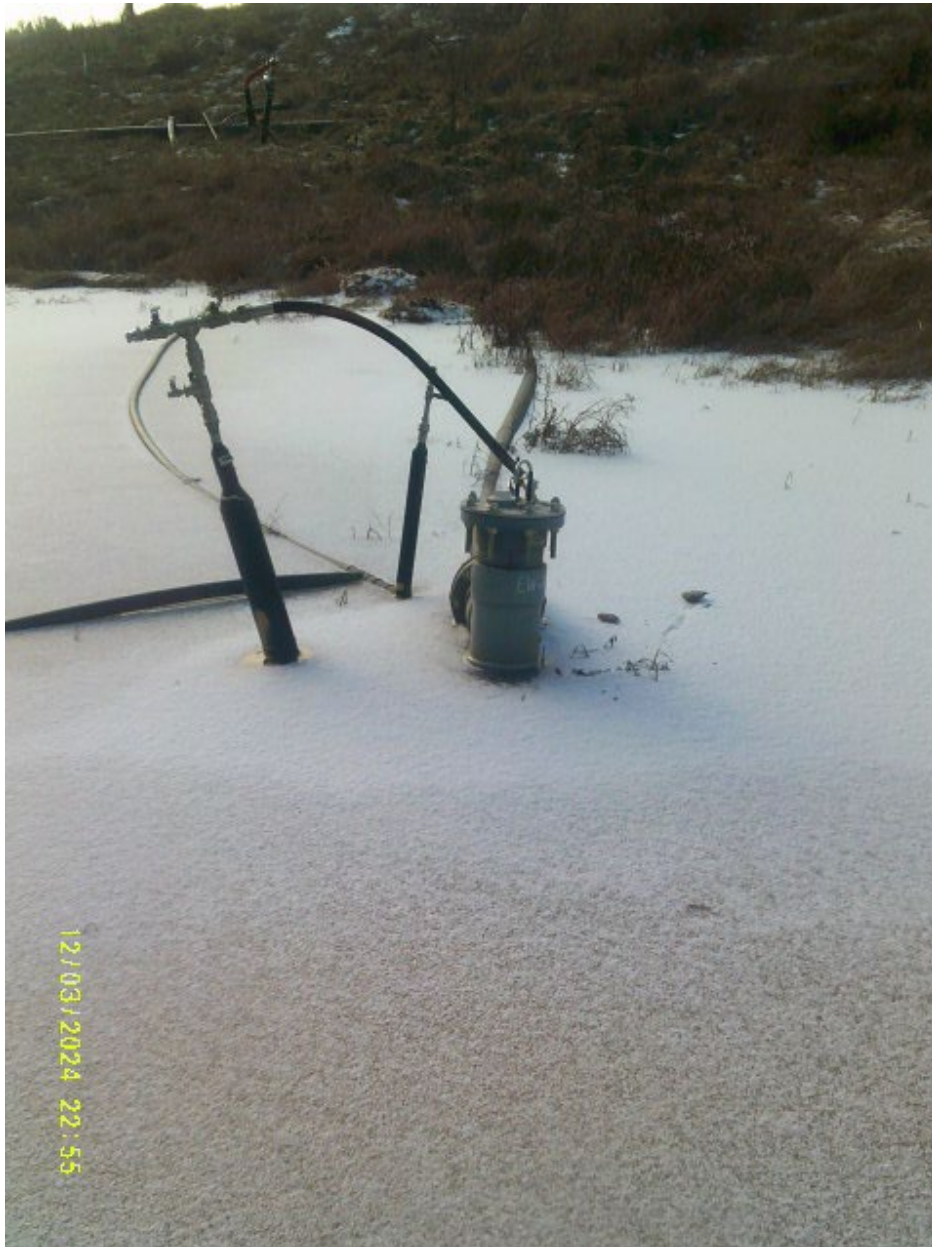
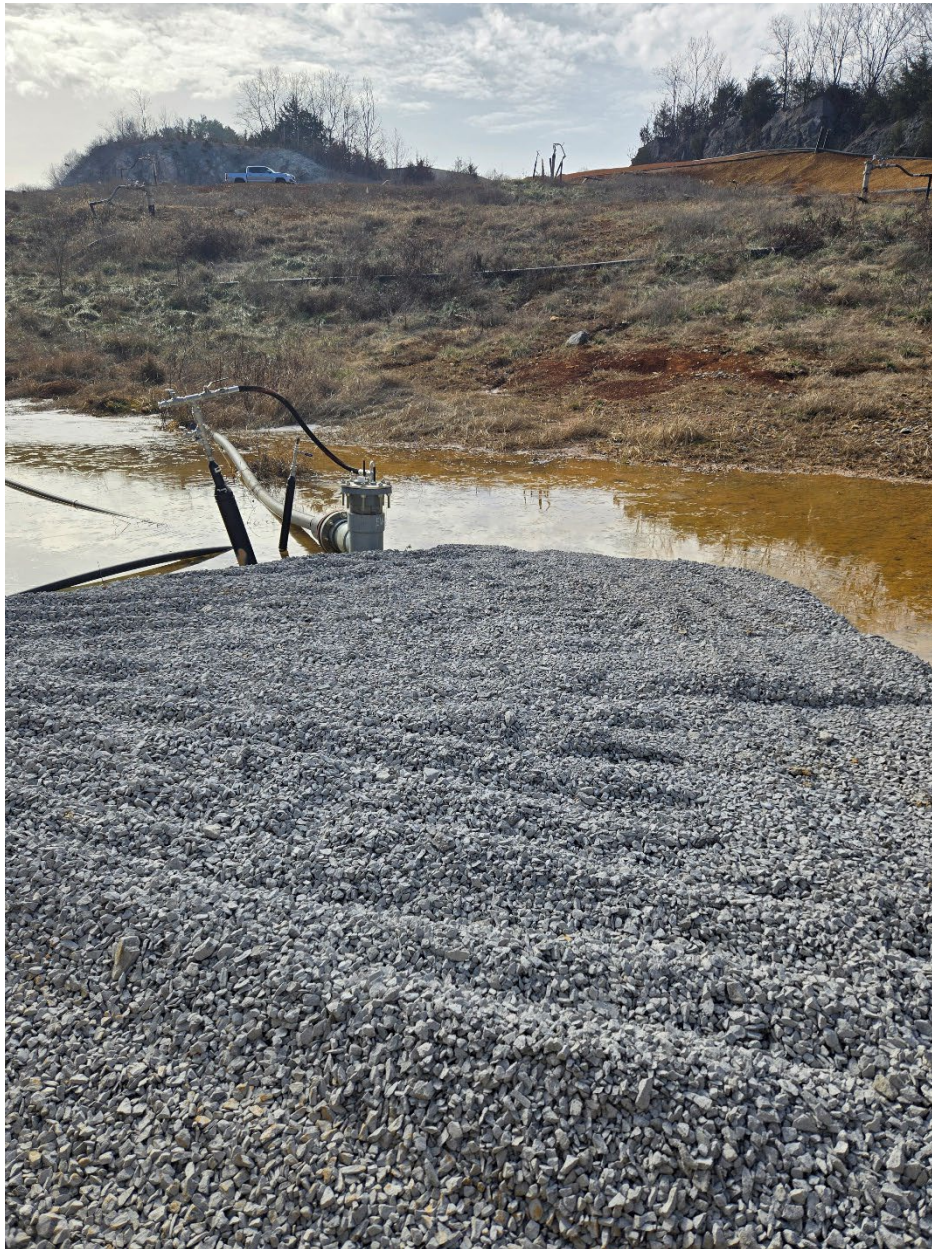
- The stroke counter on the pump in EW-36A was recently replaced due to a malfunction of the old stroke counter. SCS, SCS-OMM, and the City will continue to review the stroke counter to assess the pump's performance.
- Based on a review of the stroke counter data, the pump in EW-52 pumped approximately 6 gallons of liquid during the month of January 2025. The pump was replaced on January 27, 2025. SCS, SCS-OMM, and the City will continue to monitor the pump to assess its performance.
- EW-70 was not able to be accessed for maintaining pumps or sampling LFG liquids in January (conditions surrounding the well at the time of liquids sampling are shown in Figure 14). The City placed stone adjacent to the well to facilitate access for pump maintenance and liquids sampling (conditions after these improvements were made are shown in Figure 15).

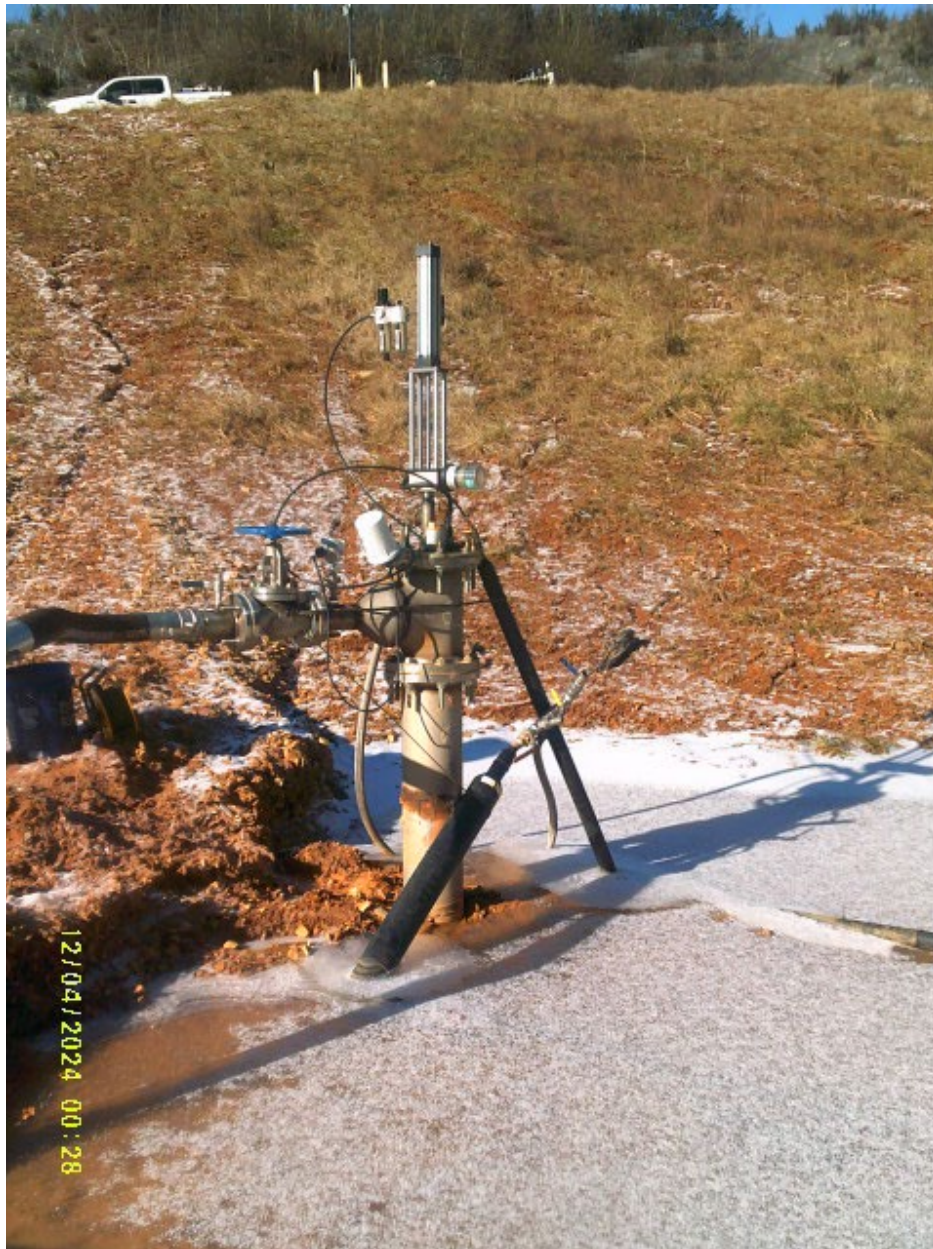
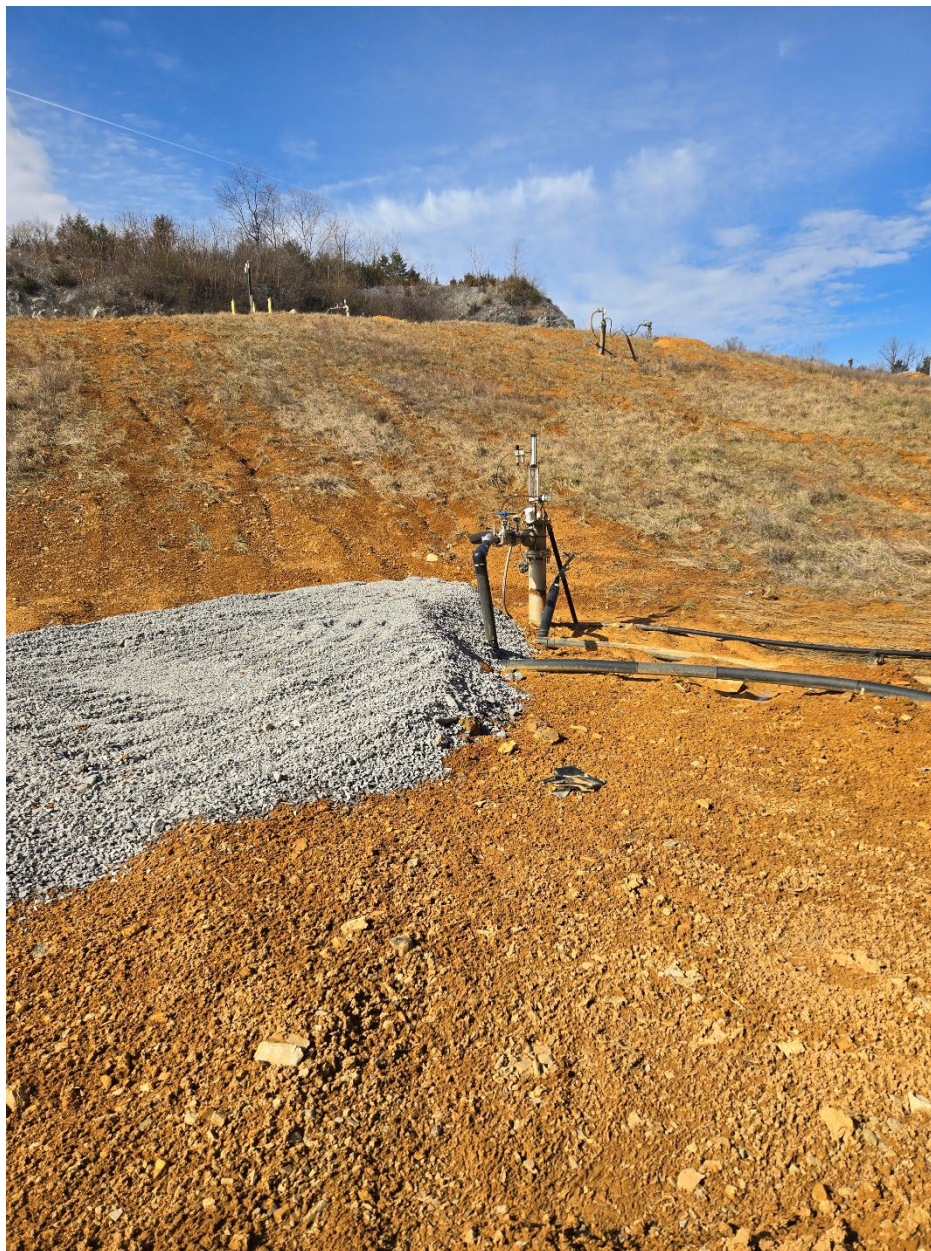
- The stroke counter on the pump in EW-78 was recently replaced due to a malfunction. The pump was replaced on January 24, 2025. SCS, SCS-OMM, and the City will continue to monitor the pump to assess its performance.
- EW-82 could not be accessed for maintenance or sampling LFG liquids in January as the area around the well was flooded (conditions surrounding the well at the time of liquids sampling are shown in Figure 16). The City placed stone adjacent to the well to facilitate access to the pump for maintenance and liquids sampling. Conditions after these improvements are shown in Figure 17.

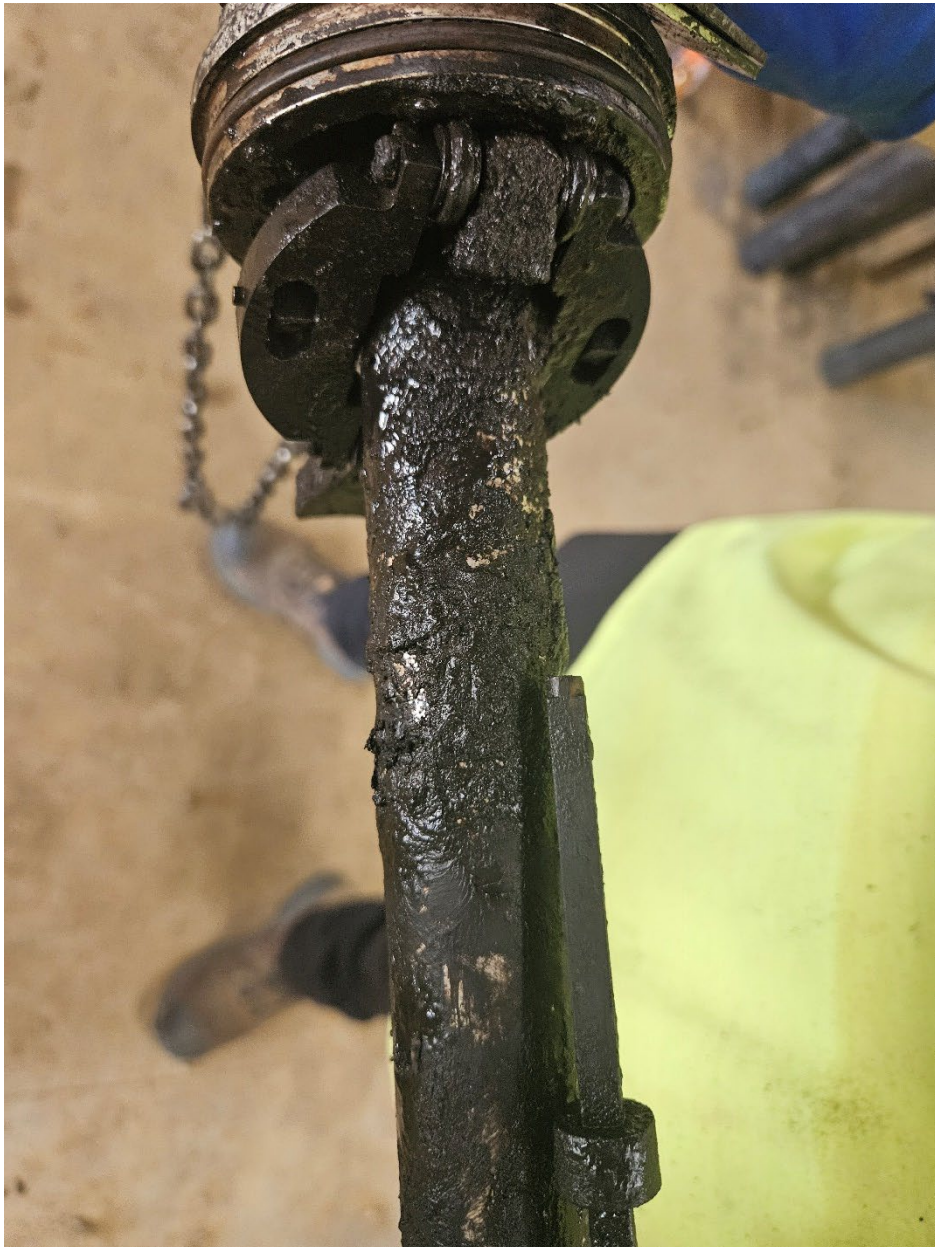
Figure 18. Solids on a Landfill Gas Liquids Extraction Pump

- When attempting to remove the pump in EW-51, SCS-OMM encountered an obstruction within the well that made removal difficult. SCS-OMM is coordinating with the City to bring a piece of heavy equipment to the well to extract and replace the pump. Pumps placed in EW-51 typically require maintenance on short intervals due to the build-up of solids on the pump. In interest of efficiency, SCS-OMM and the City are prioritizing fixes at other pumps that are more likely to extract liquid for longer before needing maintenance again. An example of typical solids build-up on and landfill gas liquids extraction pump in the SWP No. 588 Landfill is shown in Figure 18.

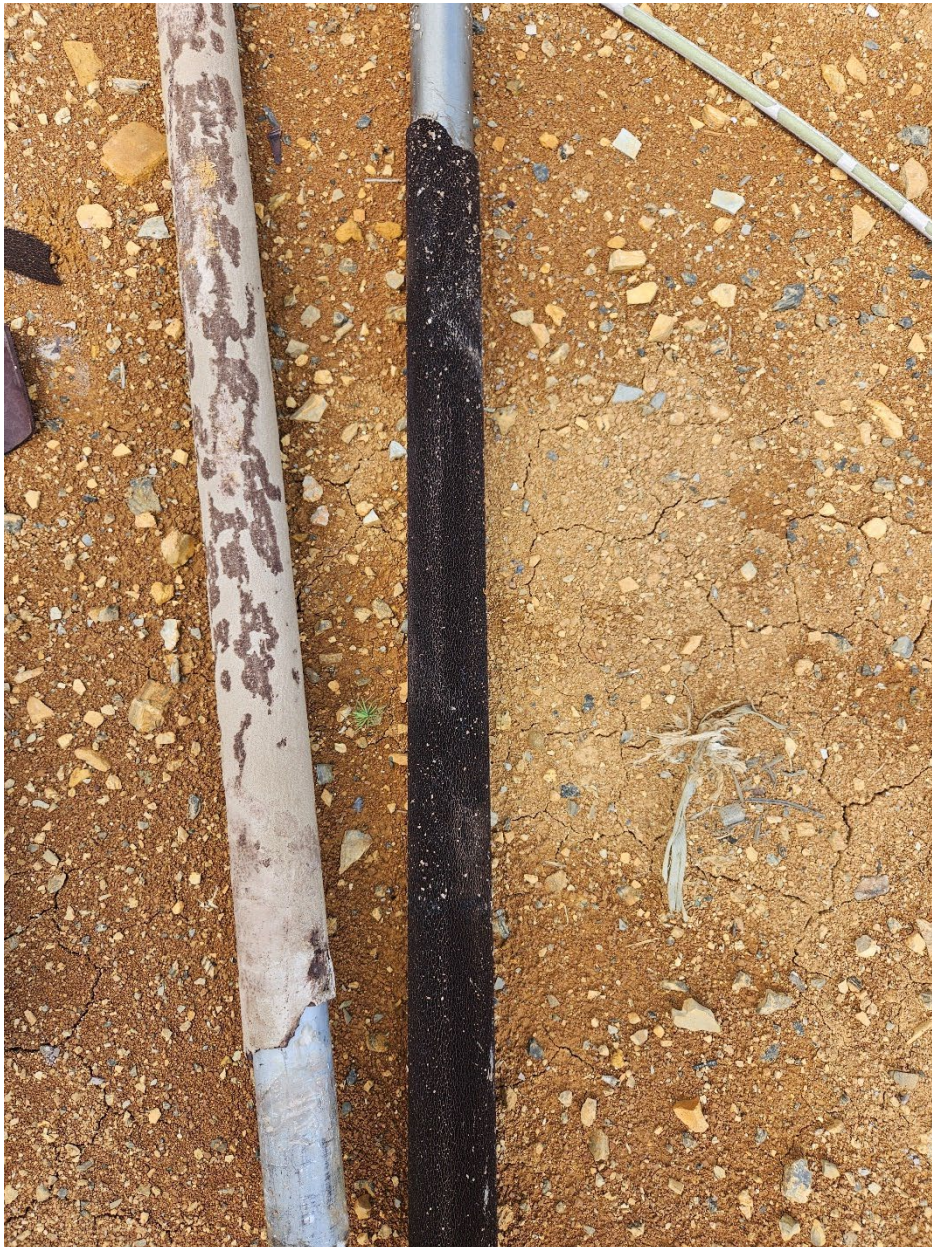
Figure 19. Solids on a Landfill Gas Liquids Extraction Pump

- Based on a review of the stroke counter data, the pump in EW-67 pumped approximately 8 gallons of liquid during the month of January 2025. SCS-FS has scheduled this pump to be pulled and inspected but noted that high forcemain pressure (believed to be caused by scaling) may be impeding function.

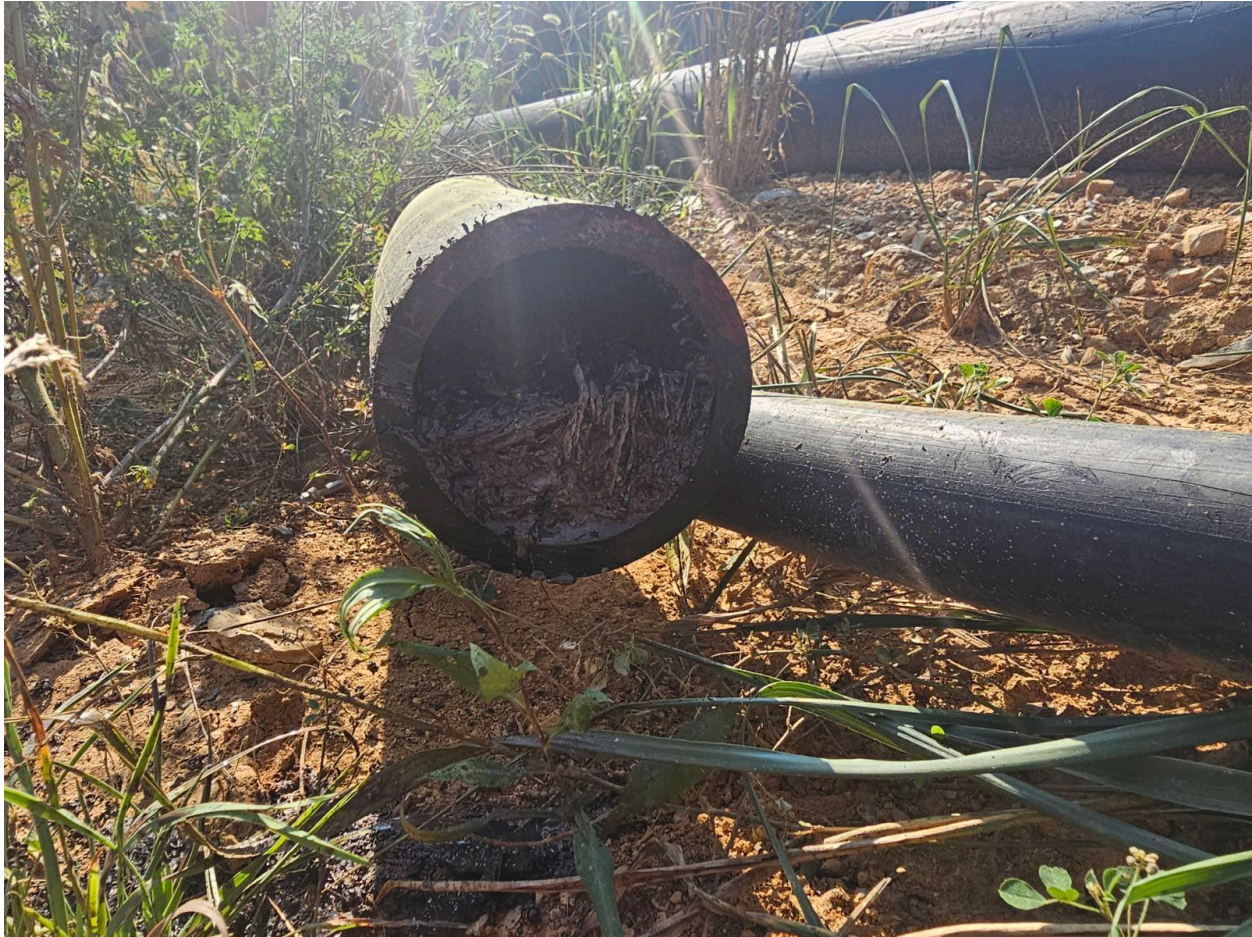
Figure 20. Solids in Landfill Gas Liquids Forcemain

In addition to the challenges associated with the individual pumps, SCS-OMM has observed high forcemain pressures and significant build-up of solids within the forcemain. An example of solids build-up within the forcemain is shown in Figure 20. This results in SCS-OMM dedicating substantial amounts of time to relieving air pressure on the system. The City is preparing bid documents for installation of additional cleanouts and air release valves in the wellfield to address the issue. Solicitation of bids for that project is scheduled for February 2025.

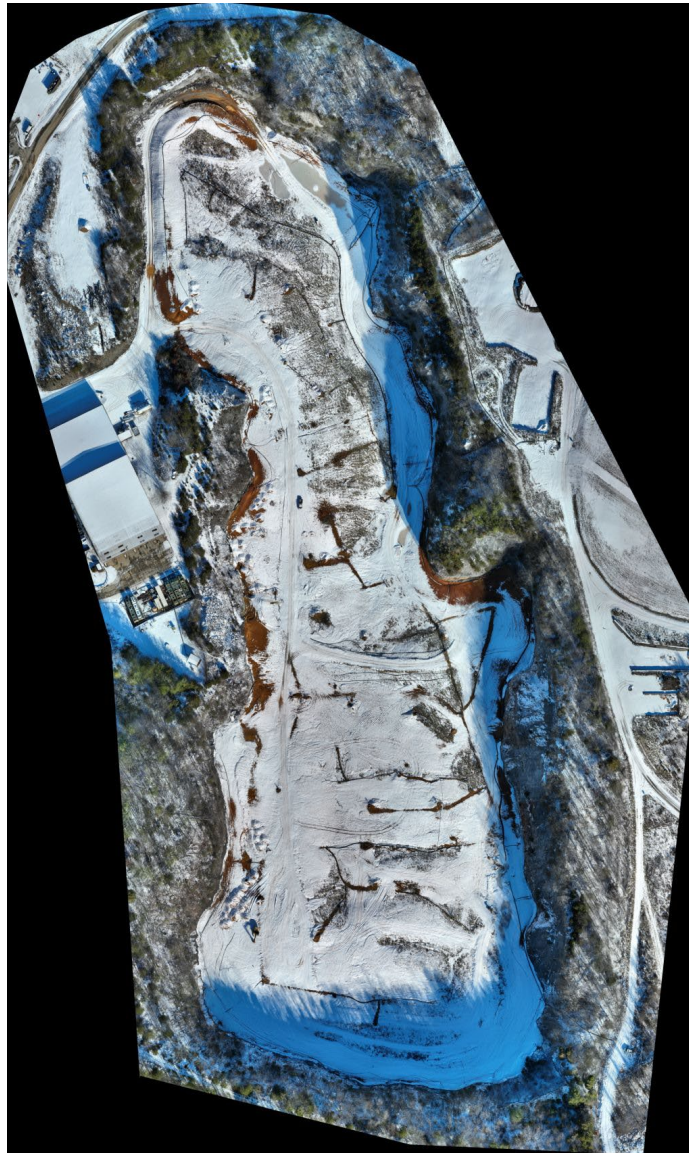
Figure 21. Aerial Photo of the SWP No. 588 Landfill

SCS collected topographic data of the Solid Waste Permit No. 588 Landfill using photogrammetric methods via an unmanned aerial vehicle (UAV or drone) on January 14, 2025. On this date there was snow present on the ground that impacted the collection of topographic data. The snow on the ground is depicted in Figure 21. The topographic data collected is shown on Sheet 4 in Appendix E.

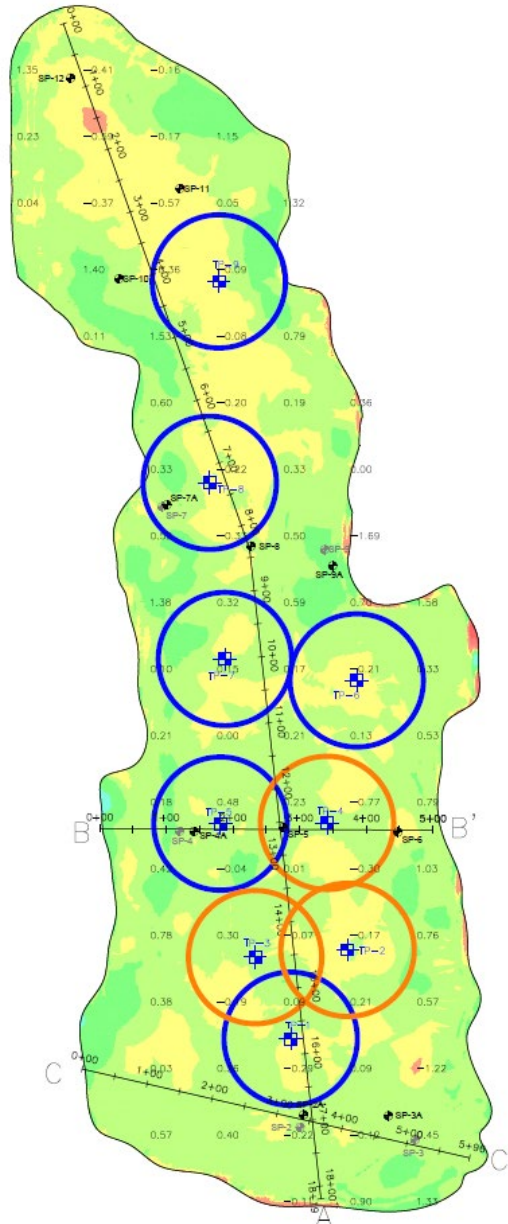
Figure 22. 1-Month Elevation Change Map

Based on a comparison of the topographic data collected on those two dates, the data shows a fill of 11,200 cubic yards across the site. Fill may have been placed on the site to address differential settlement, surface emissions, and to provide access to LFG collection vertical wells. The fill value was also impacted by the presence of snow on the facility. During that same time period, calculations indicate a “cut” volume of approximately 2,100 cubic yards. Cut volumes are typically attributed to settlement. This resulted in a net volume increase of approximately 9,100 cubic yards.

areas where elevations have increased. Darker colors indicate greater changes in elevation. This drawing is also included as Sheet 5 in Appendix E.

The locations of in-waste temperature monitoring probes are also shown on Figure 22, Figure 23, and Figure 24. The circles around the probes in each of these figures are indicative of the average borehole temperature. The circles shown are offset from the probes for clarity only and do not necessarily indicate temperatures measured at locations away from the probe. Probes with a blue circle around them typically have an average temperature less than 200 °F across the full depth of the probe. Probes with an orange circle around them typically have an average temperature greater than 200 °F and less than 250 °F across the full depth of the probe. There were no probes

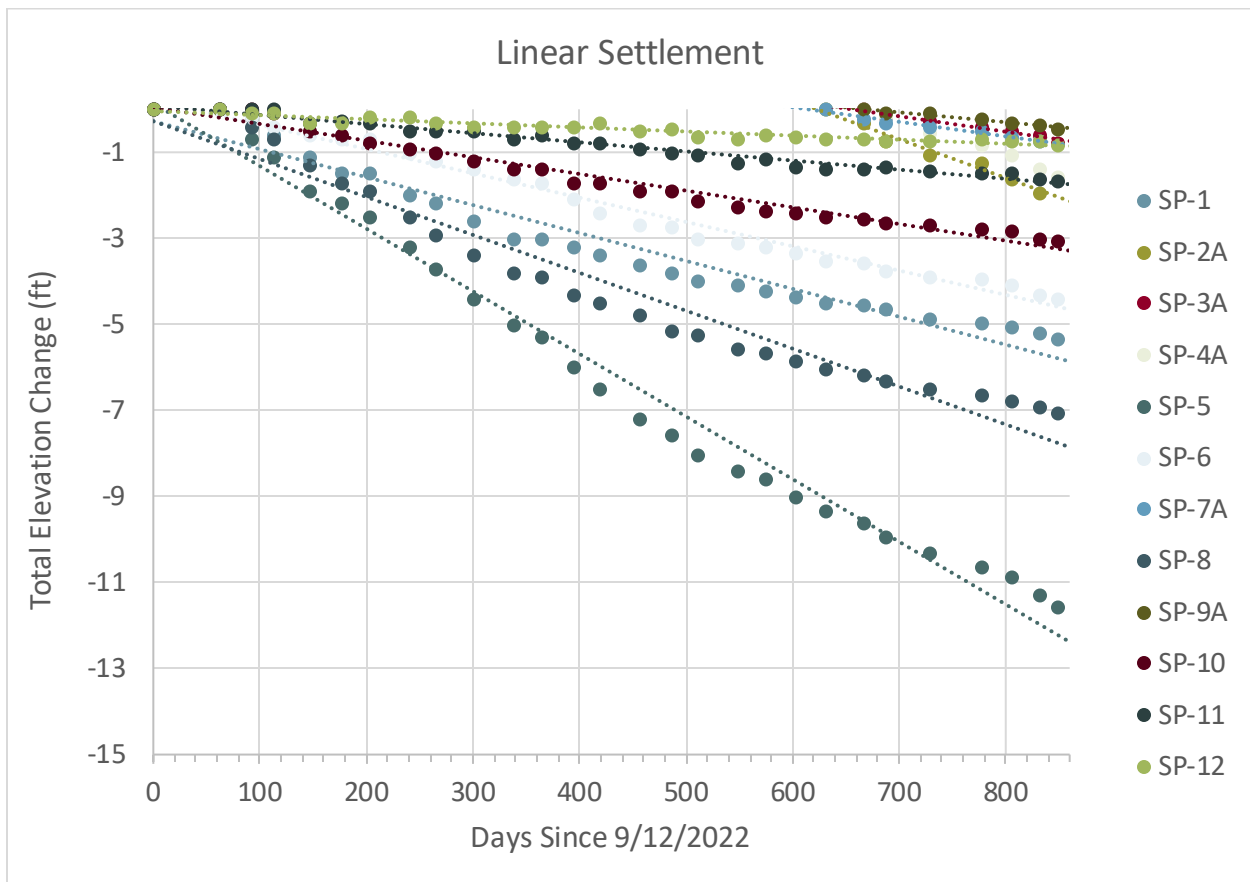
Figure 26. Elevation Change of Select Settlement Plates Over Time

Settlement Plates 1 and 2A demonstrated larger settlements than at other locations. Settlement Plates 1 and 2A are located in the southern end of the landfill. This area is the location of the gas wells and temperature probes exhibiting higher temperatures. These higher settlements values are typical of elevated temperature landfill conditions.

The settlement plates will be surveyed again during February 2025. The elevations surveyed will be compared to the elevations surveyed the previous months.

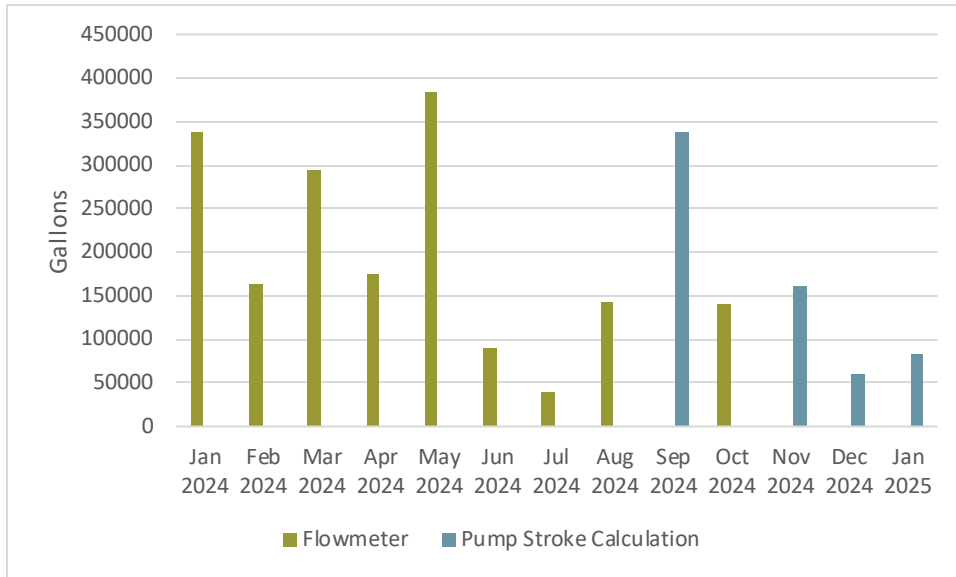
Figure G-1 Estimated Volume of Liquids Removed from Landfill Gas Wells

The progress in landfill gas liquids removal over the past year is depicted in Figure G-1. In September, November, and December 2024 and January 2025, the liquids recorded by the flowmeter were replaced with estimates from stroke counter data (colored in blue in Figure G-1) for the following reasons:

- November and December:** In November and December, the total liquids flow recorded by the SWP No. 588 primary landfill gas liquids flowmeter showed 0 gallons for several days in a row, while pump stroke counter data indicate that pumps were moving liquids. SCS investigated potential causes for the discrepancy. SCS-RMC reached out to the manufacturer of the flowmeter and received counsel that possible causes may be that liquid flowrates were simply below the threshold of the flowmeter's totalizer (1,000 gallons per day), or that air intrusion caused the flowmeter to malfunction. SCS-FS inspected the flowmeter and informed the City that there were known air pockets in the pipeline that were unable to be released during the period of zero readings. Because the flowmeter began to function normally in late December (recording typical amounts of liquid flow each day) after these air pockets were released by SCS-FS, air intrusion appears to have been the cause.
