# EVOH Deployment Suitability Assessment No. 6 Bristol Integrated Solid Waste Management Facility Solid Waste Permit No. 588

2655 Valley Drive  
Bristol, VA 24201

**SCS ENGINEERS**

02218208.05 | July 10th, 2025

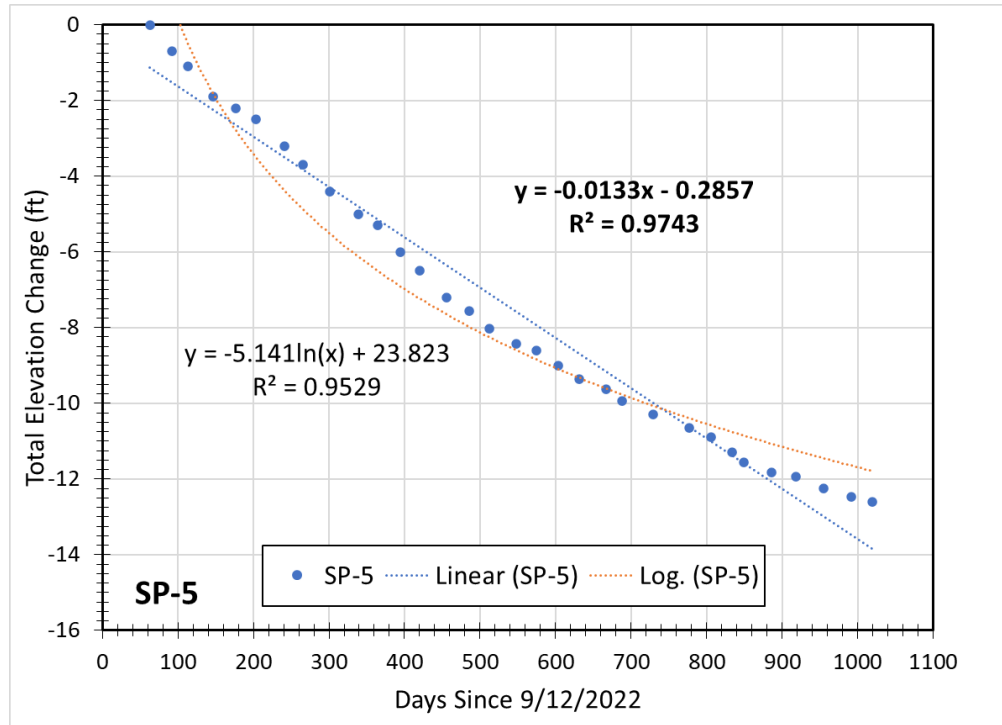
Figure 6 - Settlement Plate SP-5

Applying a linear trendline to the data for SP-5 produces an  $R^2$  equal to 0.974, indicating the strongest linear fit of all the settlement plate data (Figure 6). However, the data exhibit curvature towards the end of the record, and settlement in this area may be undergoing a transition in rate. Nevertheless, settlement appears steadily ongoing at SP-5, and the nearby temperature probes TP-4 and TP-5 continue to show elevated temperatures.

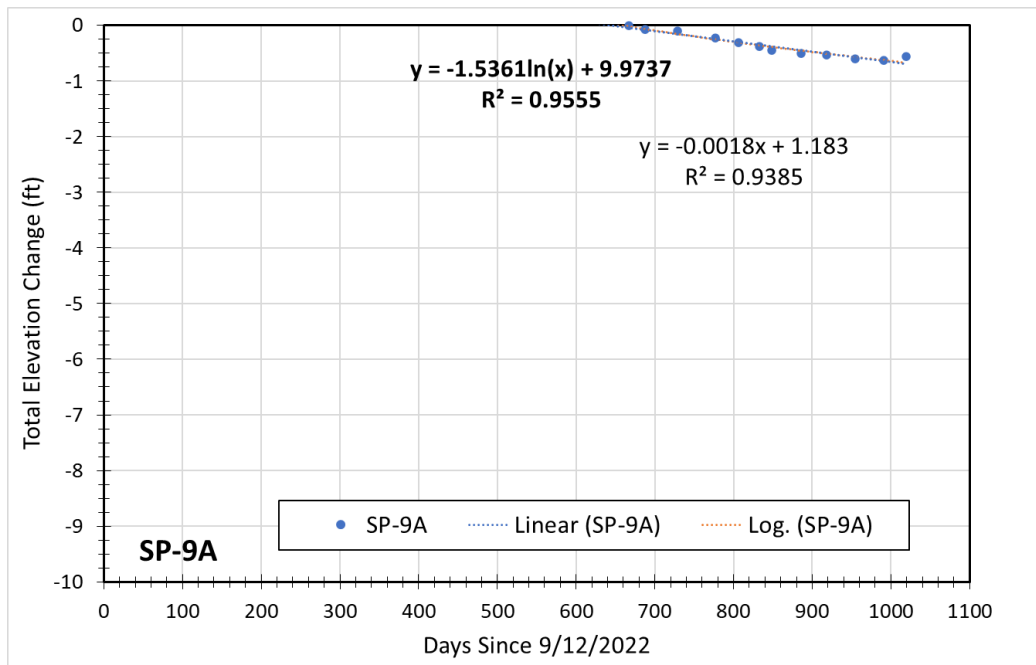
Figure 10 - Settlement Plate SP-9A

SP-9 was replaced by SP-9A for the July 31, 2024 survey. SP-9A is located 25 feet southeast of SP-9. The elevation data for SP-9A follow the linear and logarithmic trendlines comparably, and the data set is short (Figure 10).

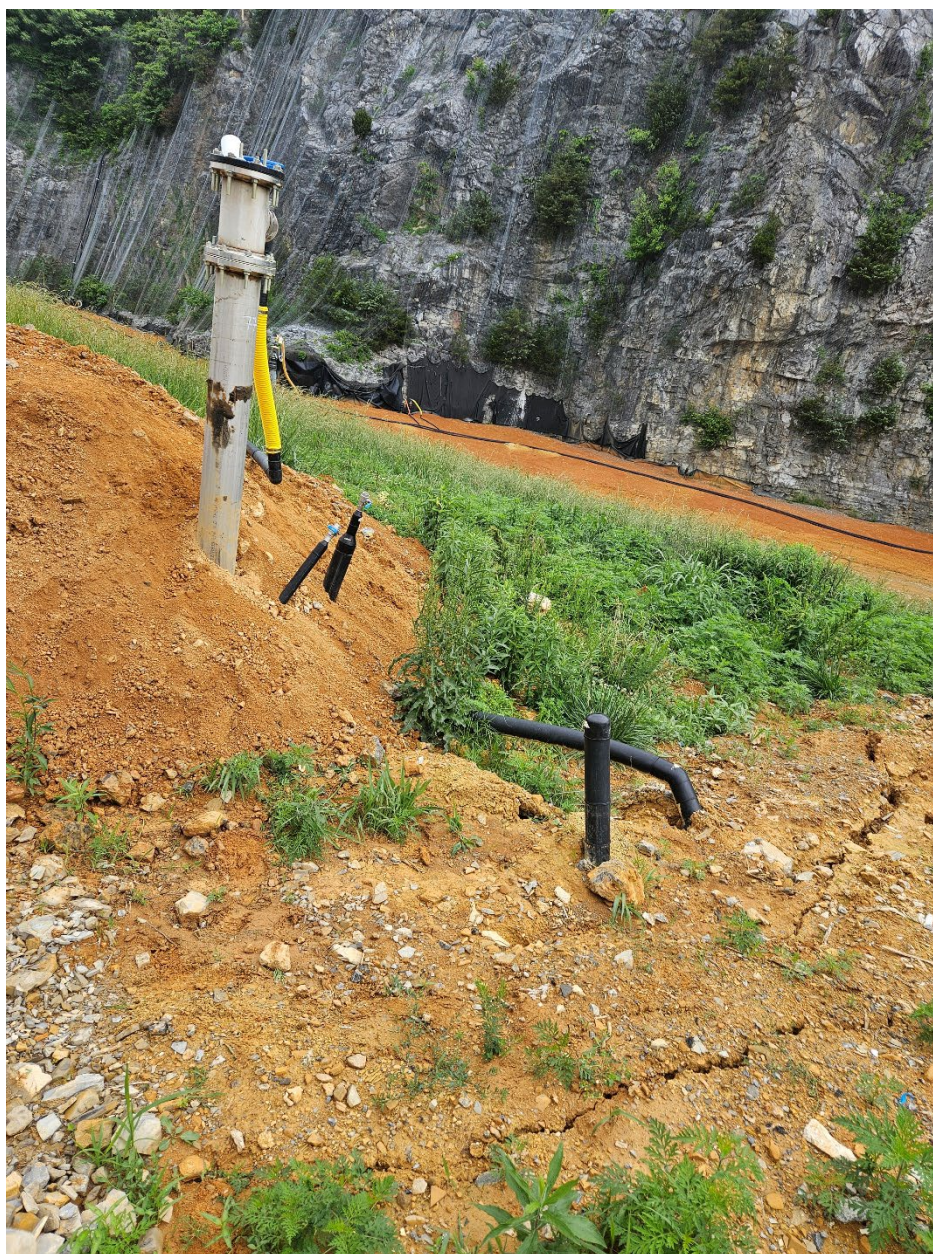
Figure 14 – Settlement Crack near EW-77

Settlement cracking was also observed near the landfill gas well EW-77 with surface cracks exceeding 1-inch width. Figure 14 shows the surface crack prior to repair work by the City.

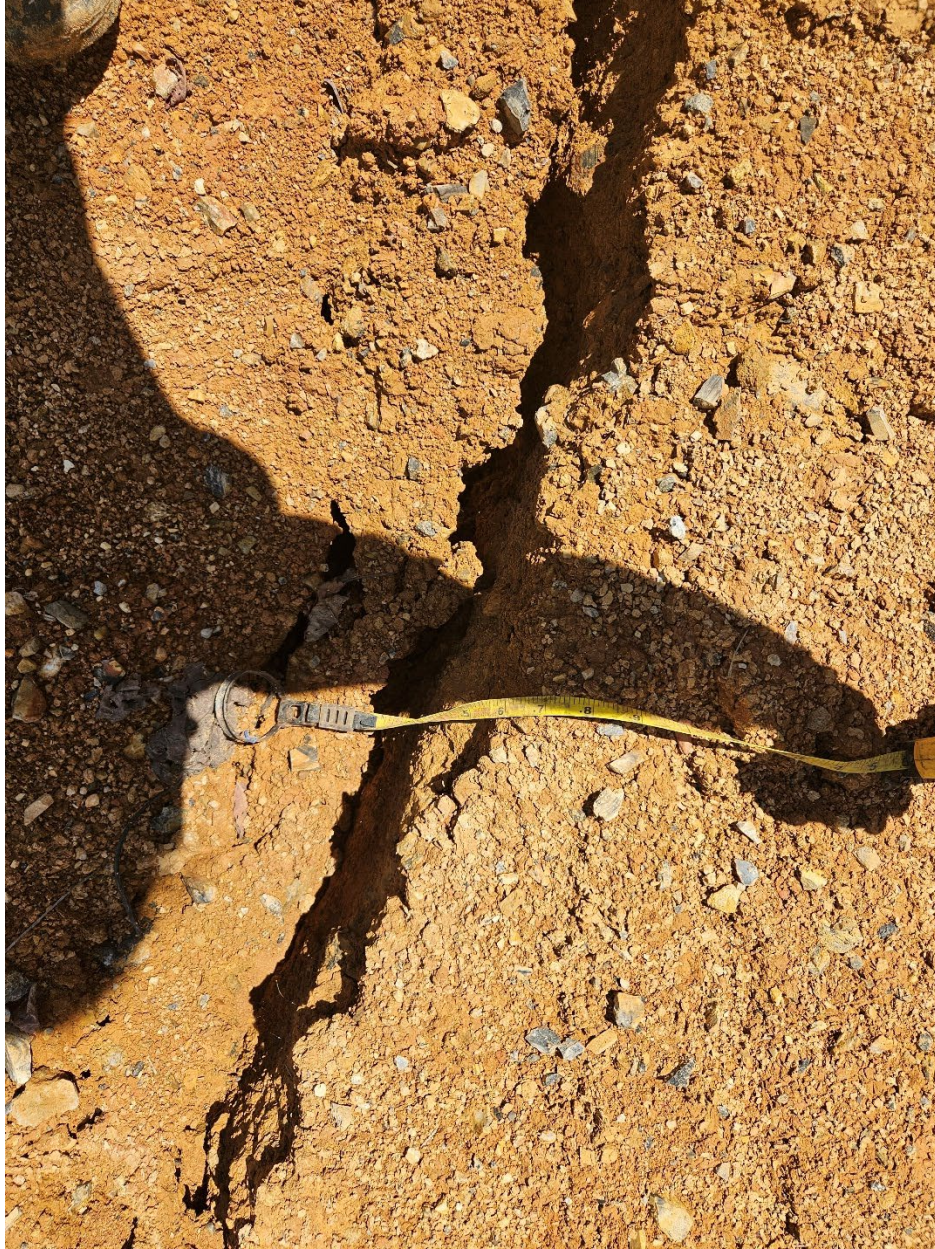
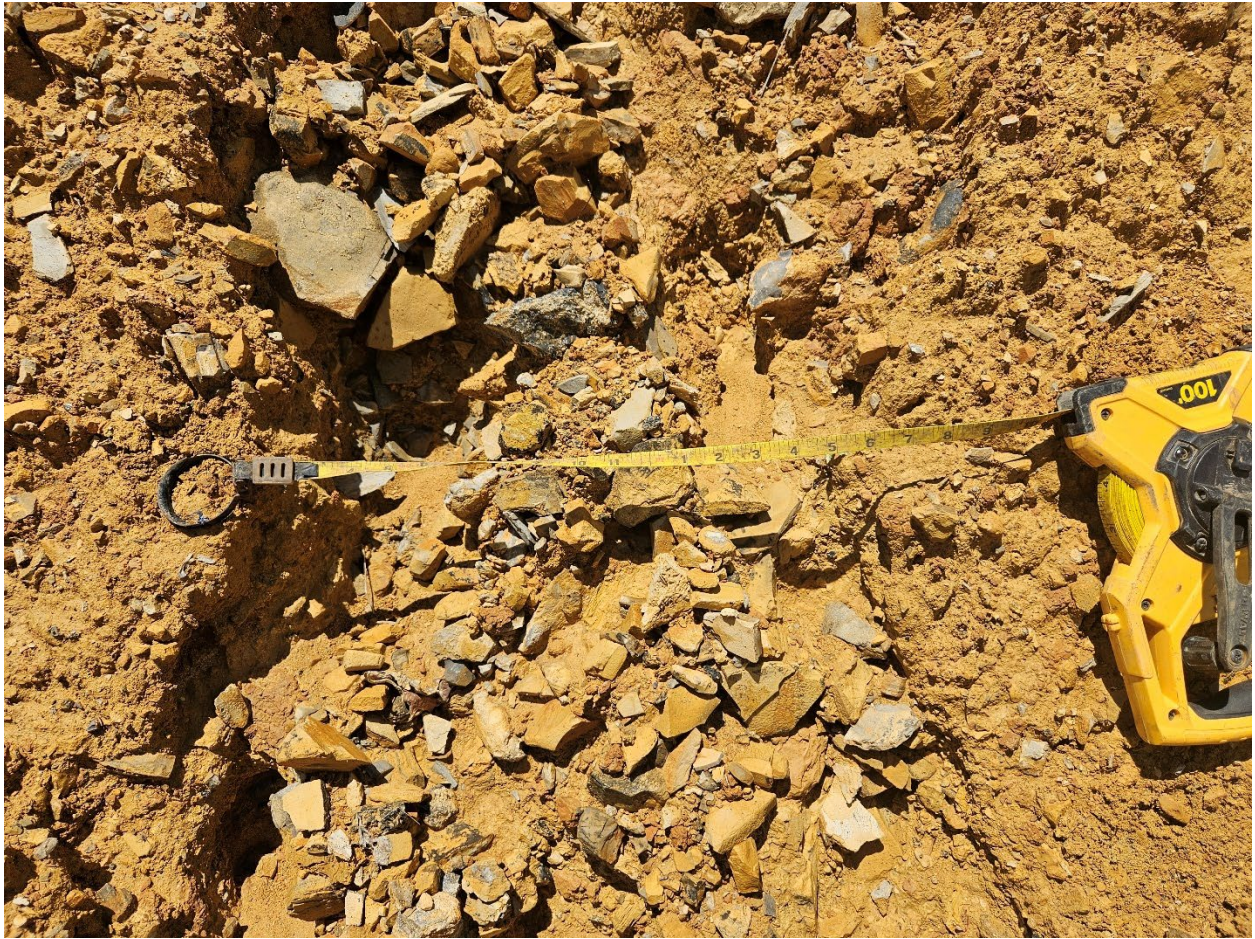
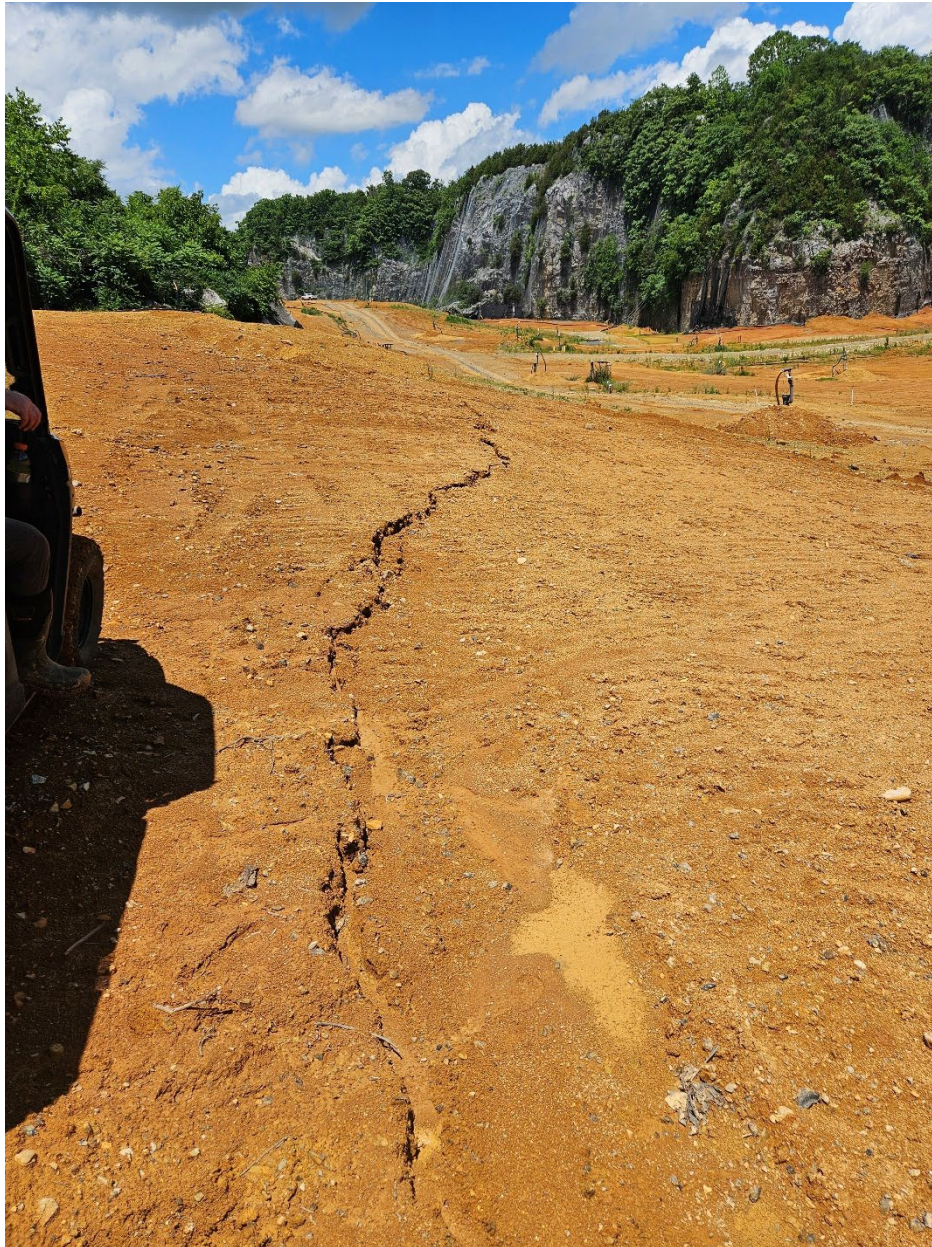
Personnel working in the quarry continue to observe surface cracks due to settlement exceeding 1-inch width. Settlement cracks and depressions were observed during the assessment period, with cracking particularly notable in the southwest region of the quarry. The surface cracks appear to follow the abrupt change in the base grade elevations and corresponding waste thickness near the subgrade bench in the quarry sidewall.

Figure 15 – Settlement Crack within the Quarry

Figure 16 – Settlement Crack within the Quarry

Figure 17 – Settlement Crack within the Quarry
