# Geomembrane Deployment Suitability Assessment No. 9

Bristol Integrated Solid Waste Management  
Facility  
Solid Waste Permit No. 588

02218208.05 | July 15th, 2026

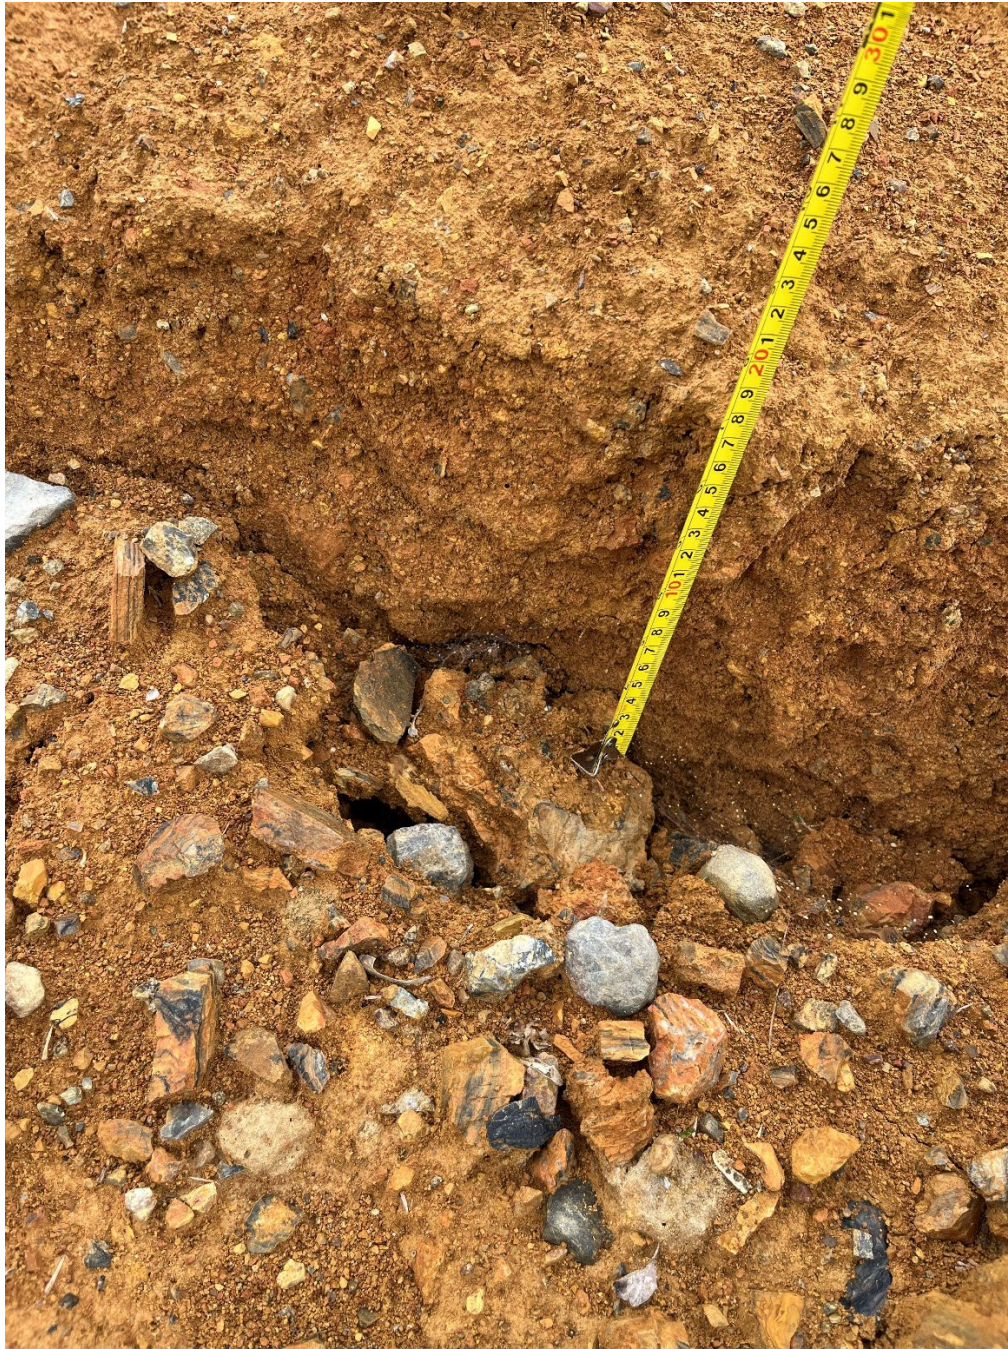
Personnel working at the landfill continue to observe settlement cracks on the landfill surface that exceed 1-inch width. The surface cracks appear to follow the abrupt change in the base grade elevations and corresponding waste thickness near the subgrade bench in the quarry sidewall. Settlement cracks and scarps observed during the current assessment period are shown Figures 2 through 5.

Figure 2. Settlement Scarp Observed in Southwest Area Near Sidewall Bench

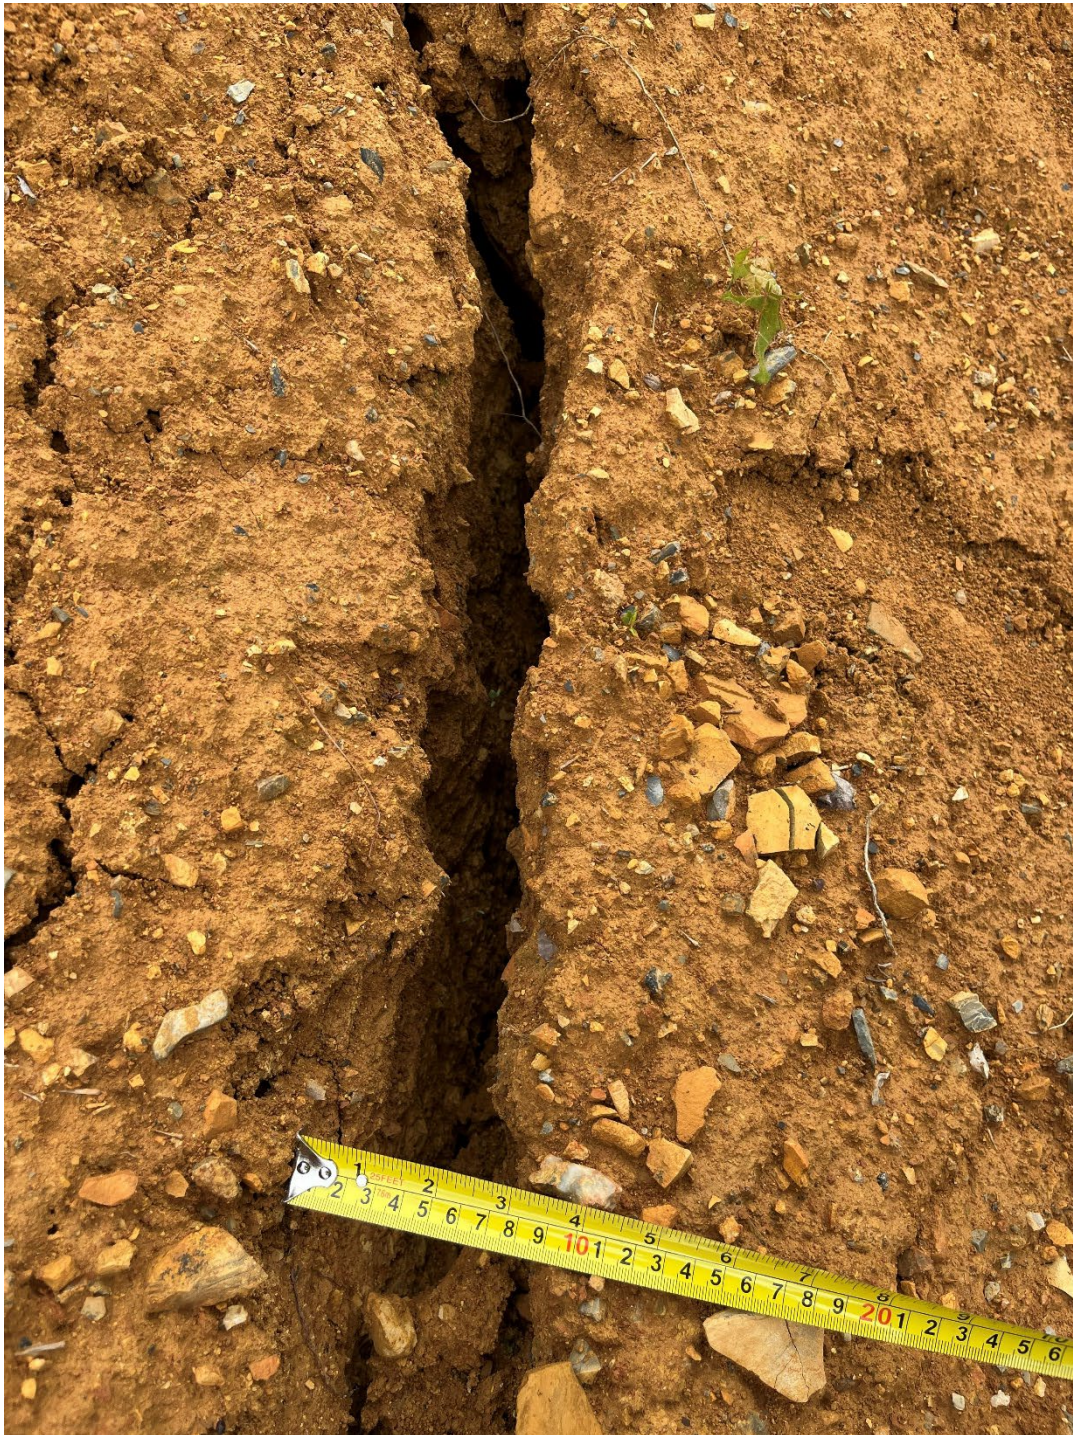
Figure 3. Settlement Crack Observed in Southwest Area Near Sidewall Bench

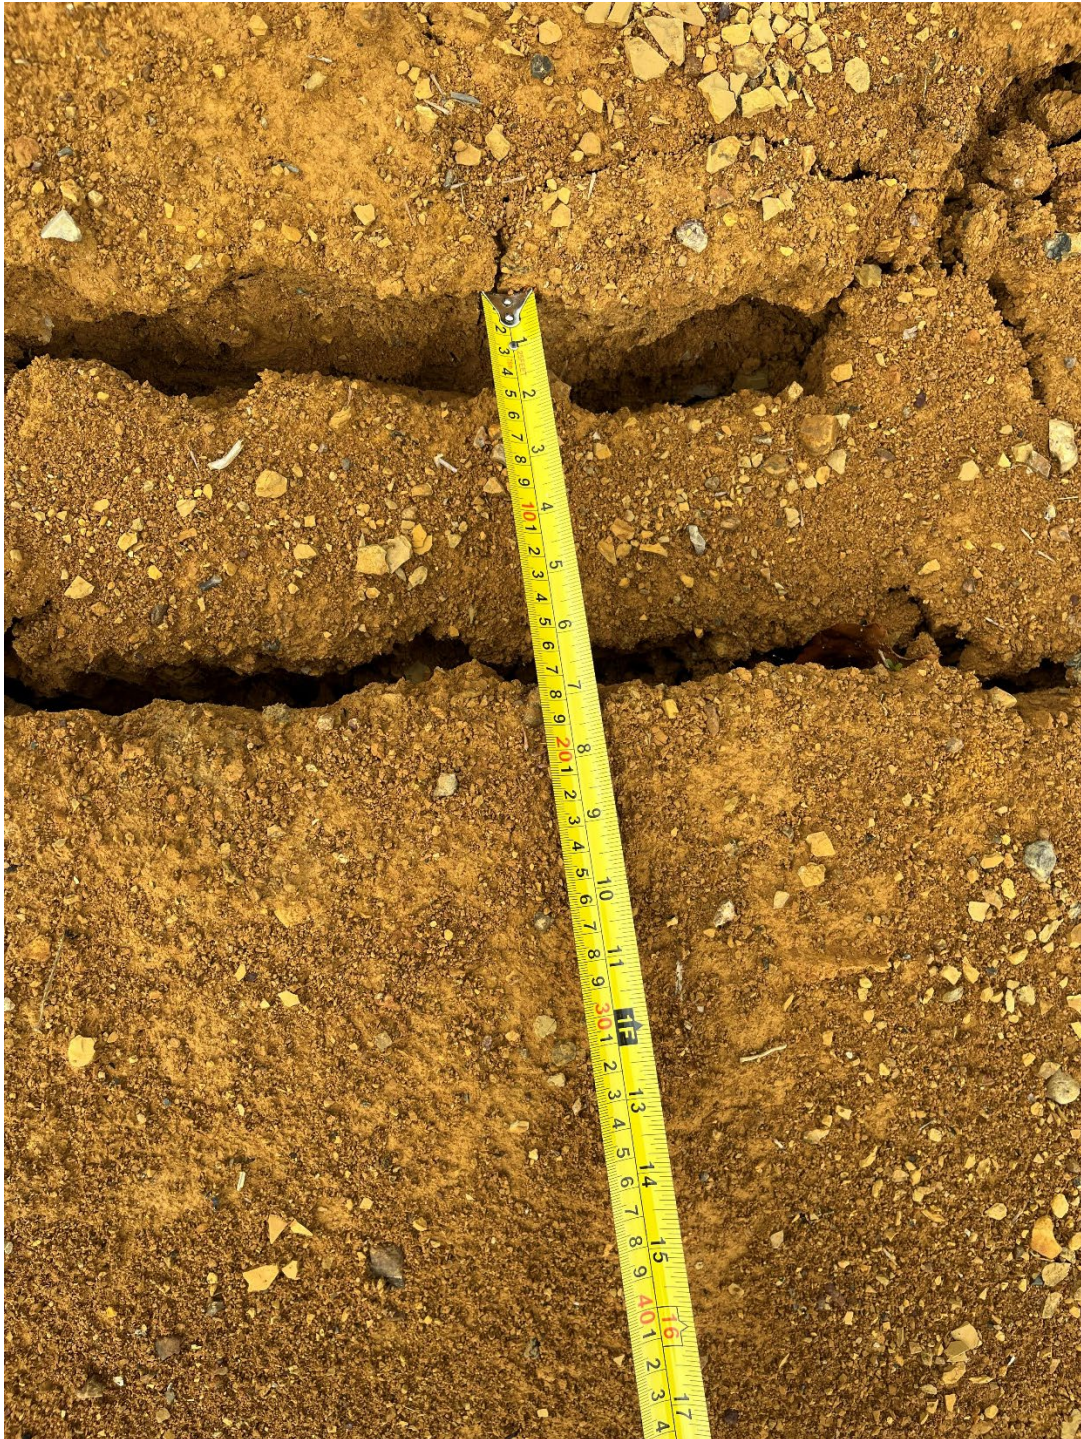
Figure 4. Settlement Crack Observed in Southwest Area Near Bench in Sidewall

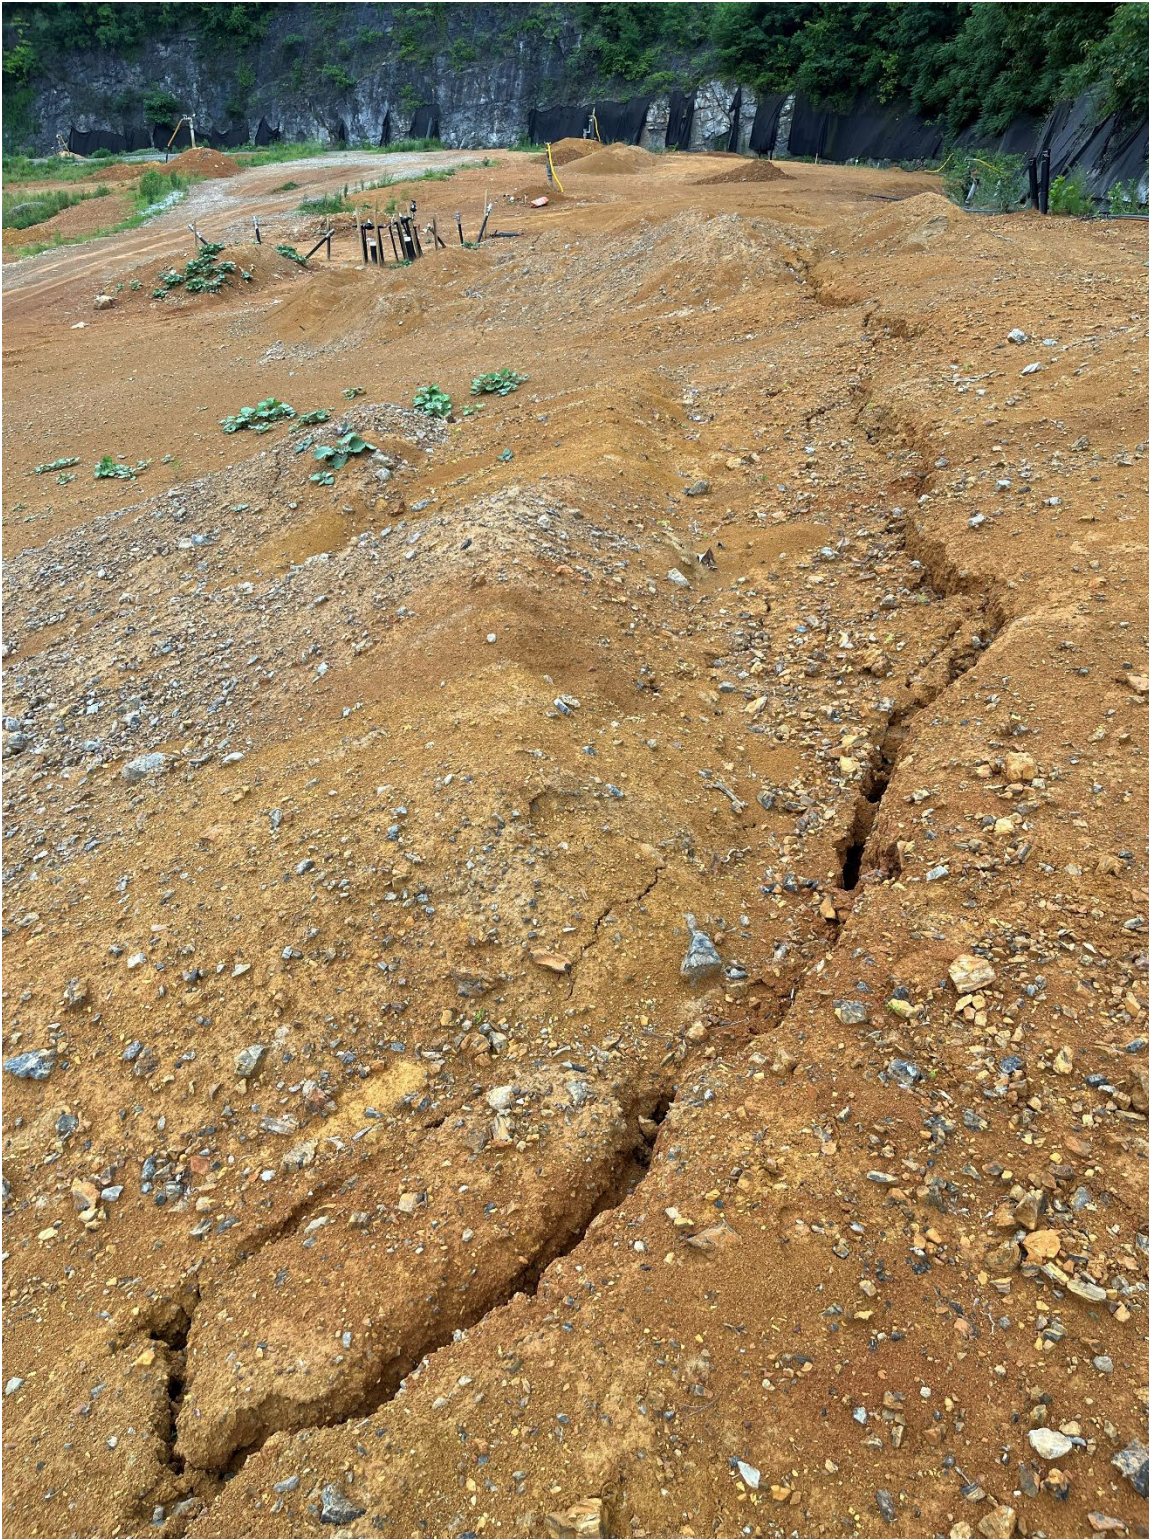
Figure 5. Settlement Crack Overview

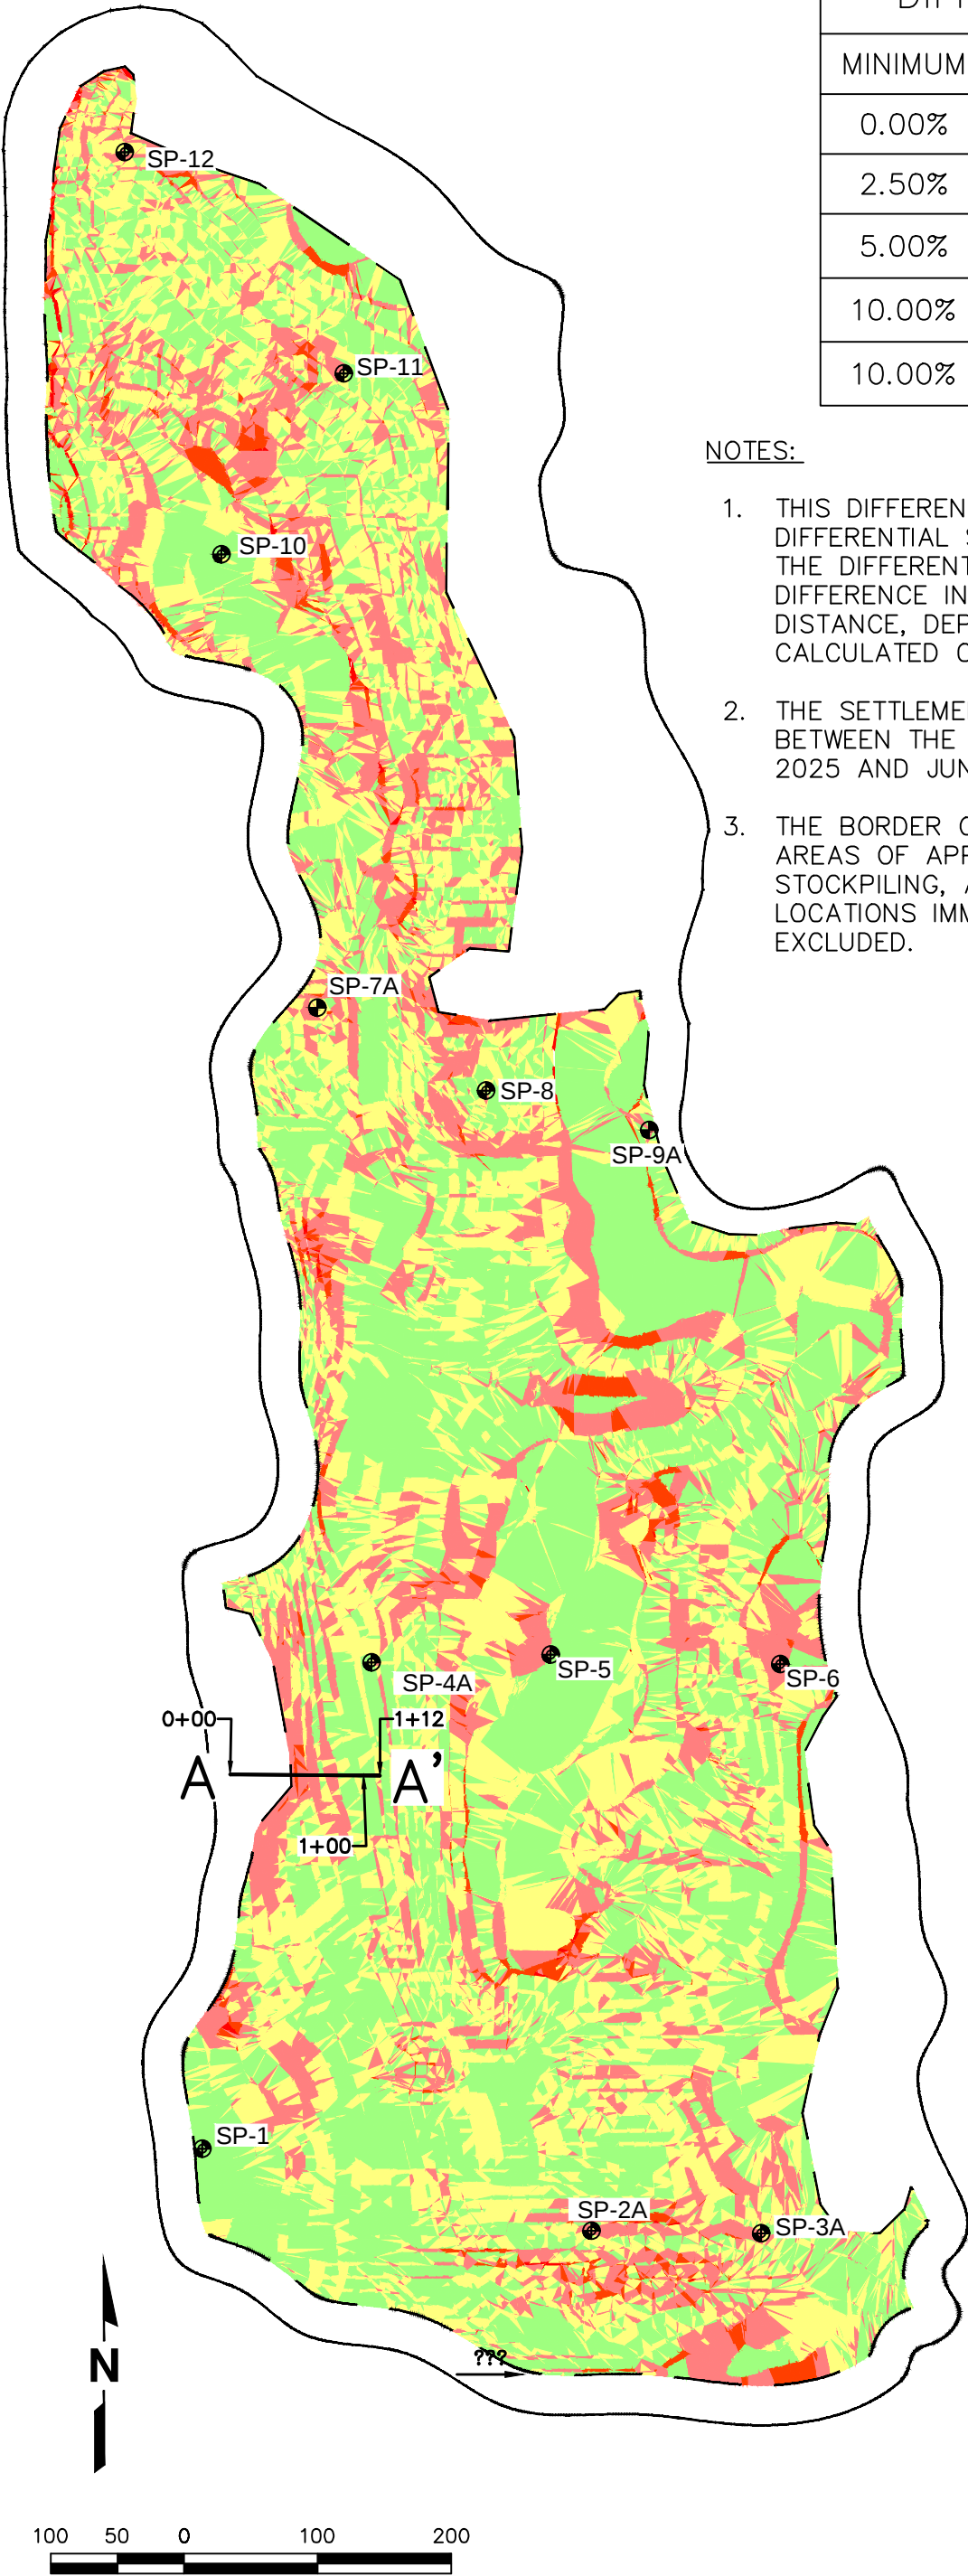
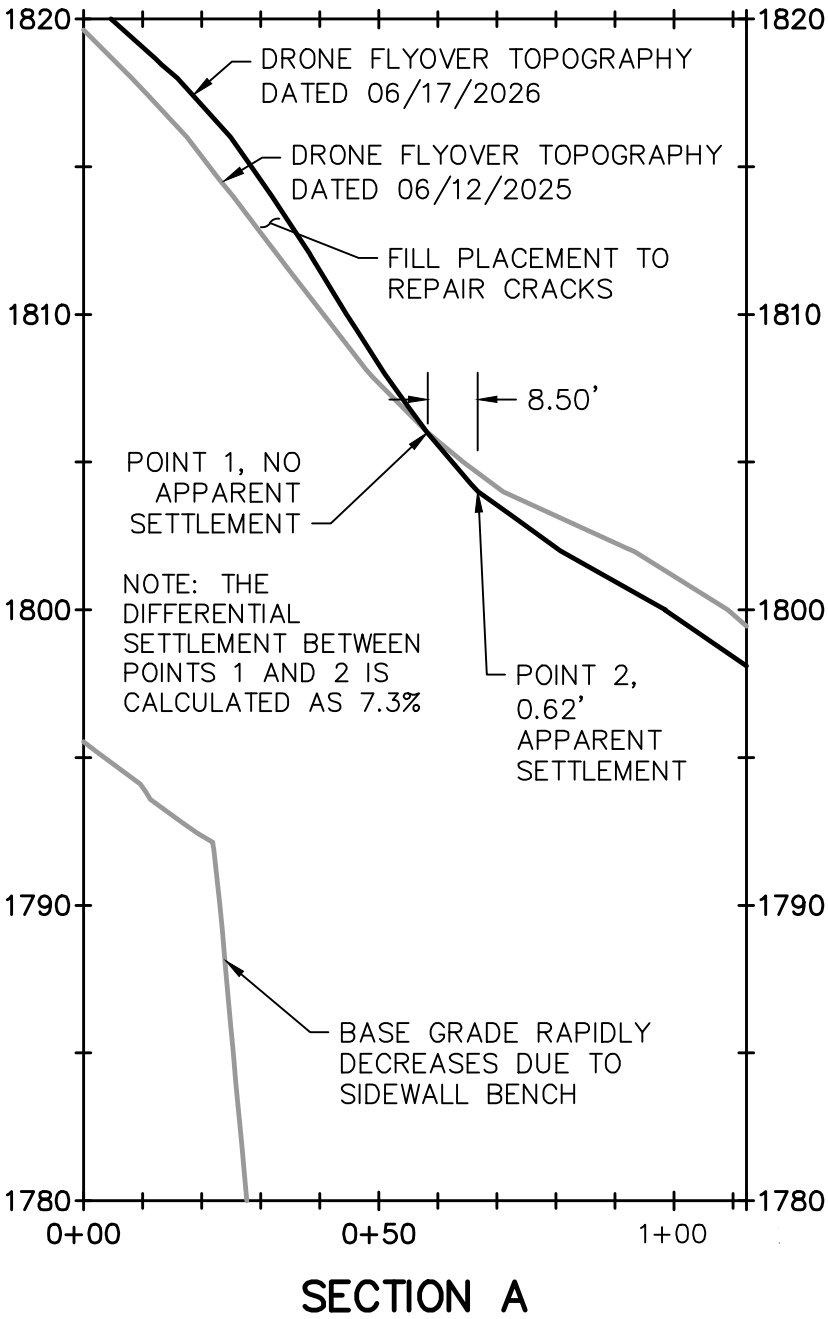
Differential Settlement Map

The differential settlement map included in Attachment A was prepared to better visualize differential settlement across the landfill surface. The map was prepared using topography data from the SCS drone flyovers dated June 12, 2025, and June 17, 2026. The respective Monthly Compliance Reports describe the methodology and equipment used for each flyover. Autodesk's AutoCAD Civil 3D software was used to complete a volumetric analysis between the two topographic surfaces, generating a new surface consisting of the elevation change between the two original surfaces. The slope between any two points on the new surface is equivalent to the ratio of differential settlement to the amount of horizontal distance.

The analysis area in Attachment A was limited to exclude areas of apparent fill due to construction and ongoing operational work within the landfill. Additionally, the limits of the analysis area was offset from the sidewall due to the drone measurement variability near this area caused by vegetation and interpolation along the sidewall.

1. THIS DIFFERENTIAL SETTLEMENT MAP SHOWS THE ESTIMATED DIFFERENTIAL SETTLEMENT ACROSS THE LANDFILL SURFACE AREA. THE DIFFERENTIAL SETTLEMENT IS SHOWN AS THE RATIO OF THE DIFFERENCE IN CALCULATED SETTLEMENT OVER A UNIT HORIZONTAL DISTANCE, DEPICTED AS A PERCENTAGE. SETTLEMENT VALUES WERE CALCULATED OVER AN APPROXIMATE 1-YEAR PERIOD.
2. THE SETTLEMENT IS CALCULATED USING THE ELEVATION DIFFERENCE BETWEEN THE AERIAL TOPOGRAPHY DATA CAPTURED ON JUNE 12, 2025 AND JUNE 17, 2026 BY SCS ENGINEERS.
3. THE BORDER OF THE ANALYSIS AREA WAS ADJUSTED TO REMOVE AREAS OF APPARENT FILL CAUSED BY RECENT CONSTRUCTION WORK, STOCKPILING, AND OTHER OPERATIONAL ACTIVITIES. ADDITIONALLY, LOCATIONS IMMEDIATELY ADJACENT TO THE SIDEWALL WERE EXCLUDED.
