# EVOH Deployment Suitability Assessment No. 8 Bristol Integrated Solid Waste Management Facility Solid Waste Permit No. 588

2655 Valley Drive  
Bristol, VA 24201

02218208.05 | January 8th, 2026

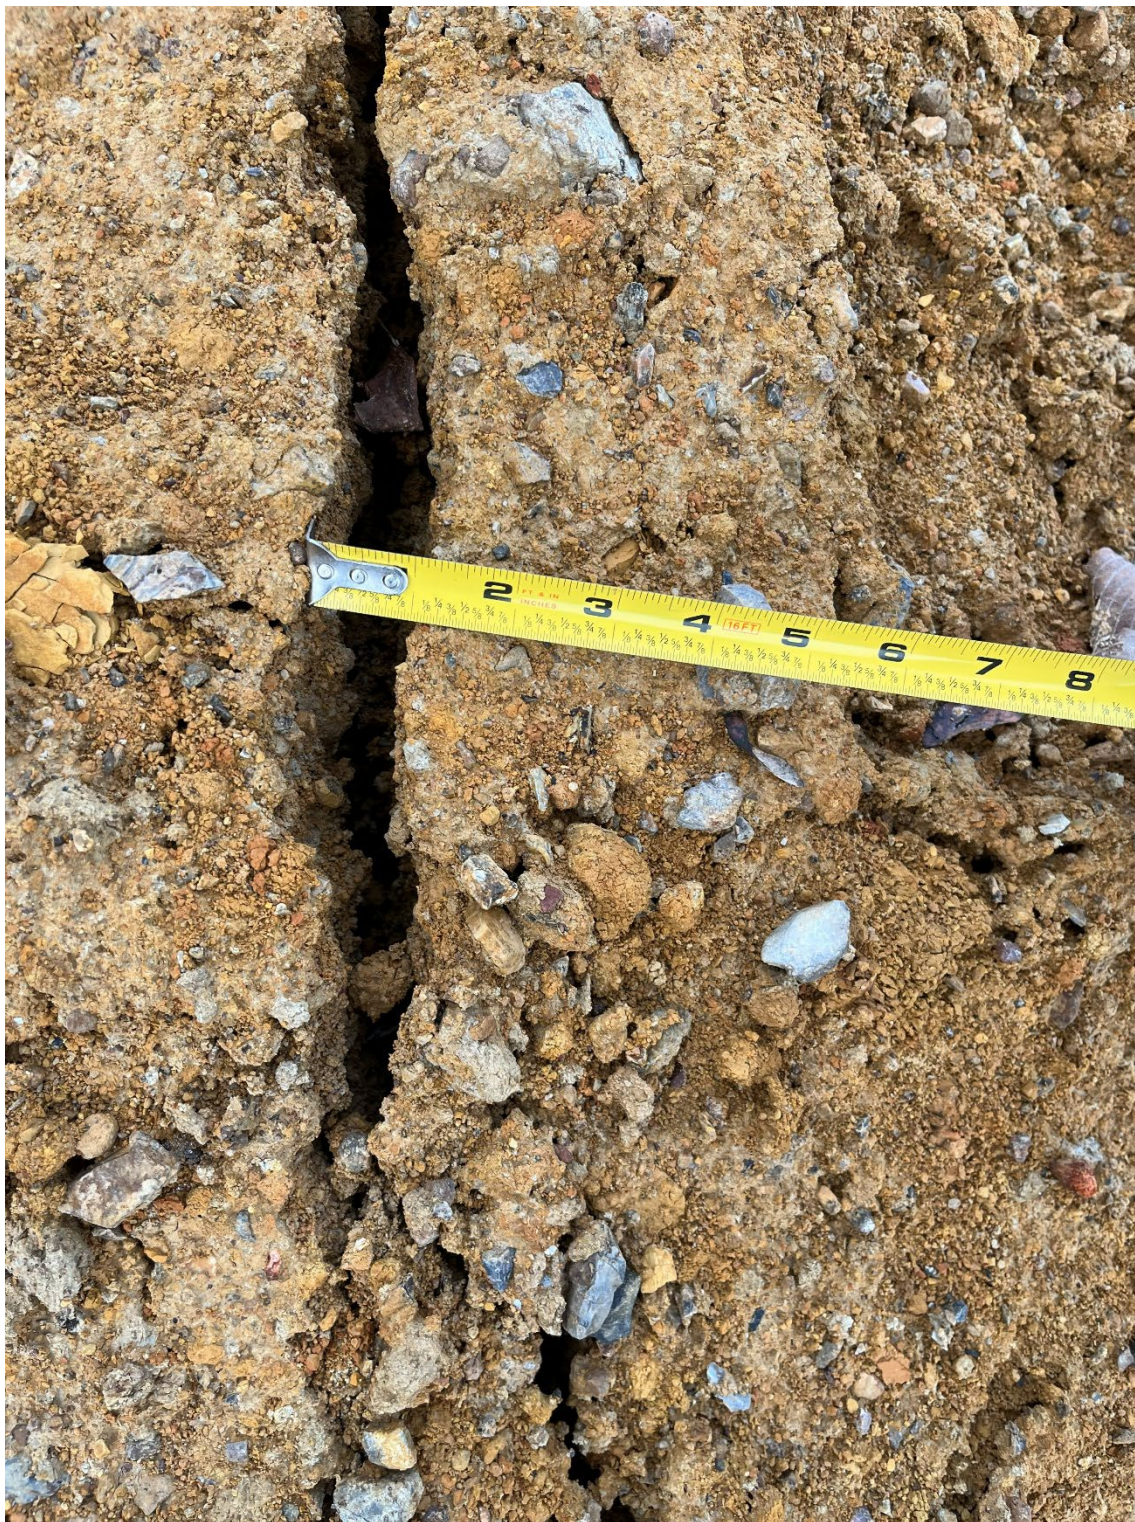
Personnel working at the landfill continue to observe settlement cracks on the landfill surface that exceed 1-inch width. Settlement cracks and surface depressions observed during the current assessment period are shown in the photographs of the landfill surface on the following pages. The locations photographed include the southwest area of the landfill near a bench in the sidewall (Figures 14, 15, and 16). The remaining photographs (Figures 17 and 18) were taken in the northern portion of the landfill, near the access road entrance into the landfill.

Figure 14 – Settlement Crack Observed in Southwest Area Near Sidewall Bench

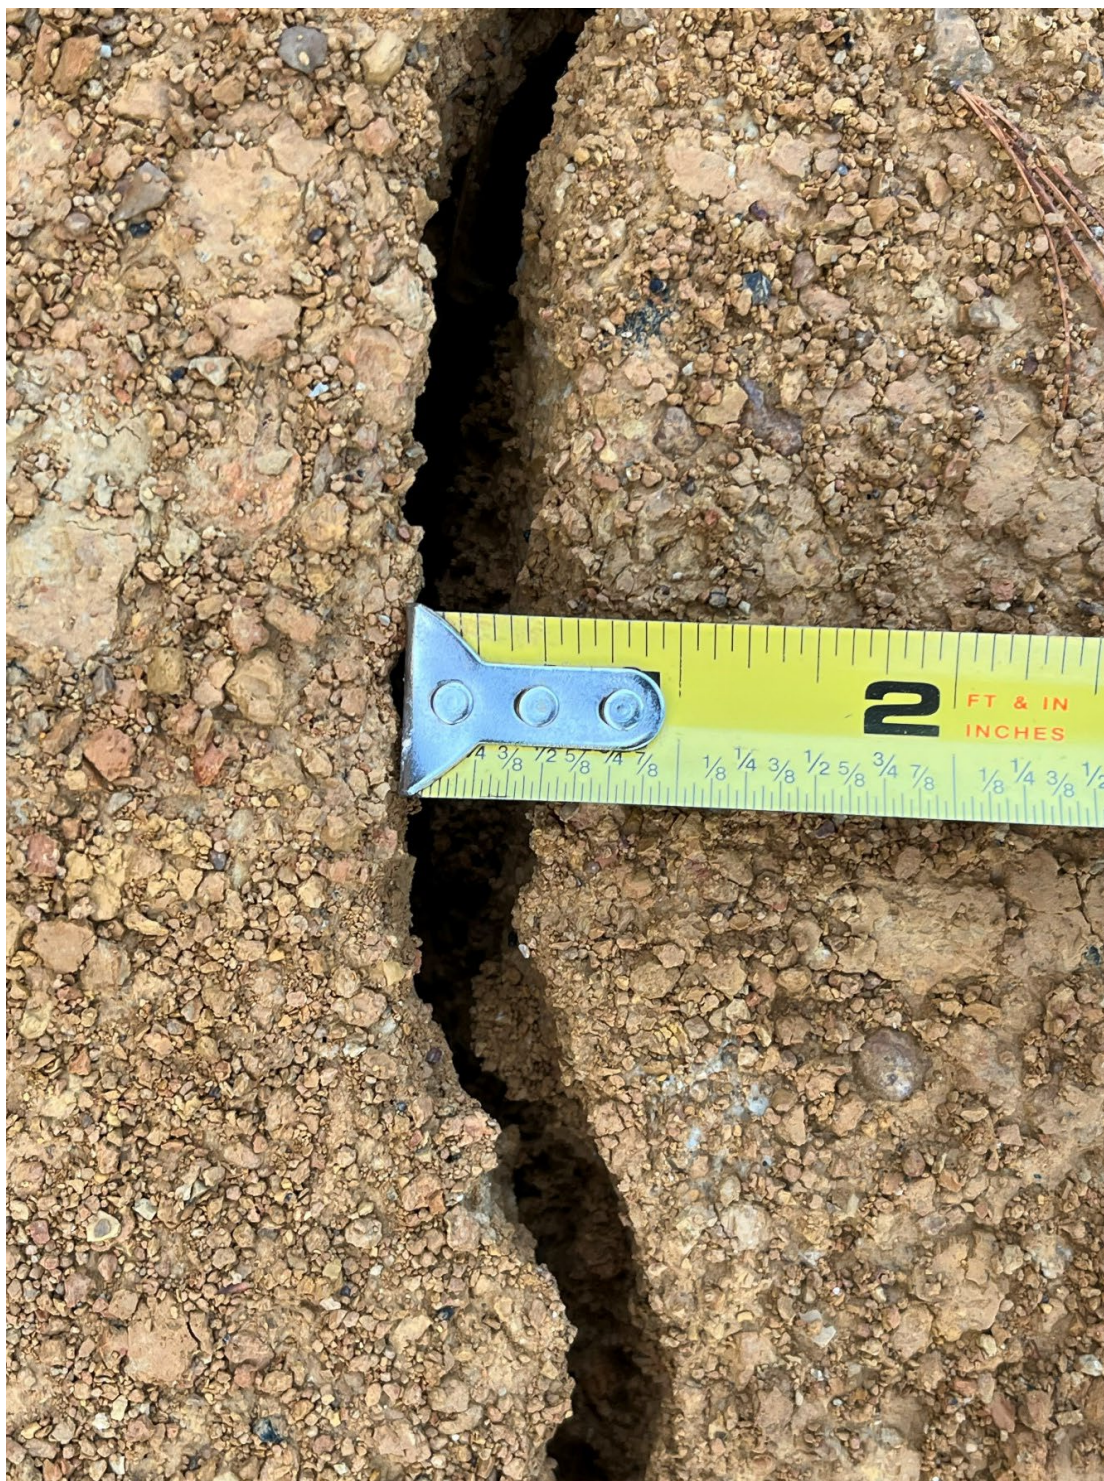
Figure 15 – Settlement Crack Observed in Southwest Area Near Sidewall Bench

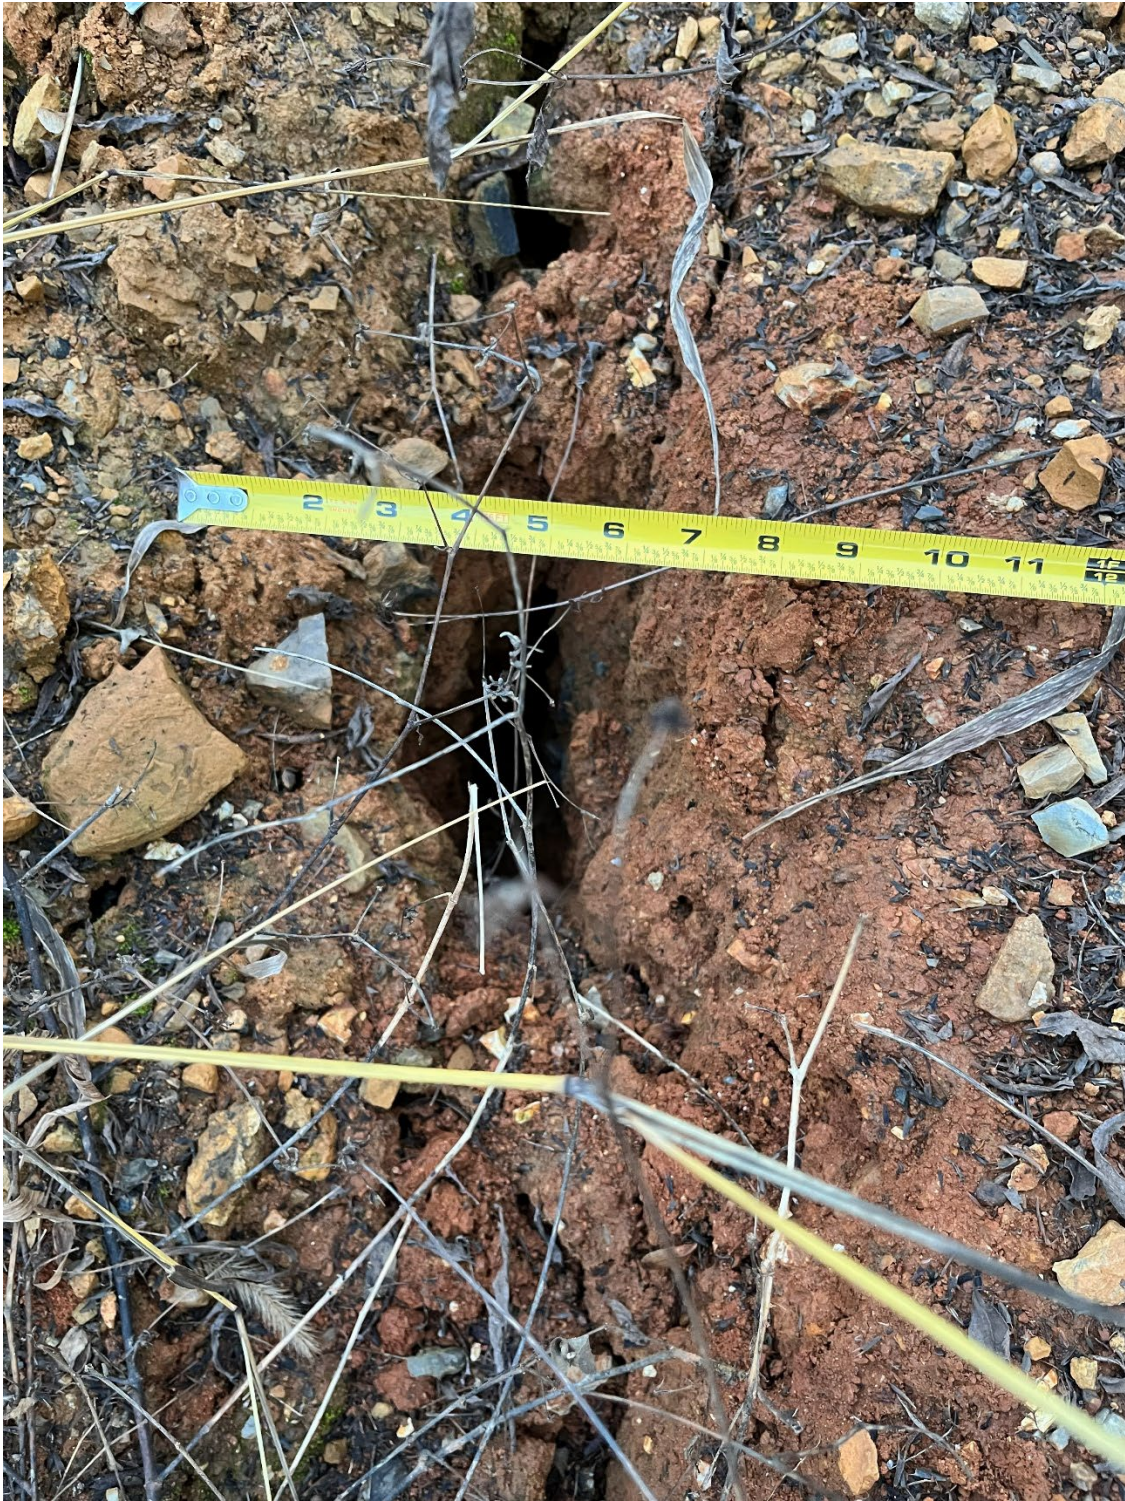
Figure 17 – Settlement Crack Observed in Northern Area Near the Access Road Entrance

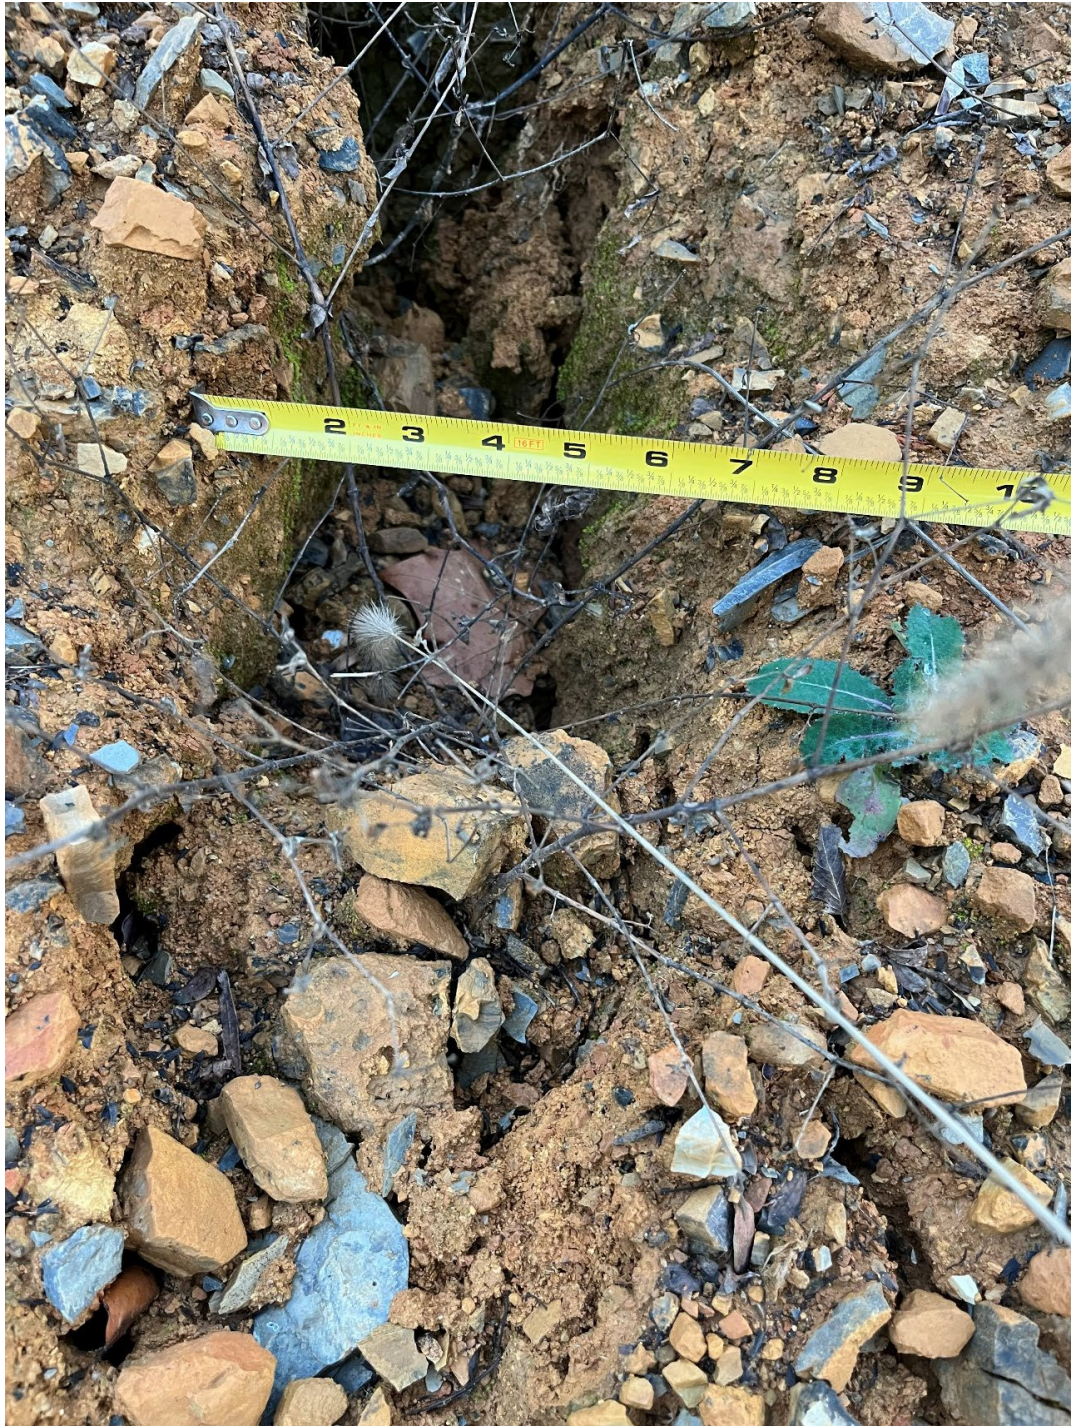
Figure 18 – Settlement Crack Observed in Northern Area Near the Access Road Entrance
