# EVOH Deployment Suitability Assessment No. 7 Bristol Integrated Solid Waste Management Facility Solid Waste Permit No. 588

2655 Valley Drive  
Bristol, VA 24201

**SCS ENGINEERS**

02218208.05 | October 7th, 2025

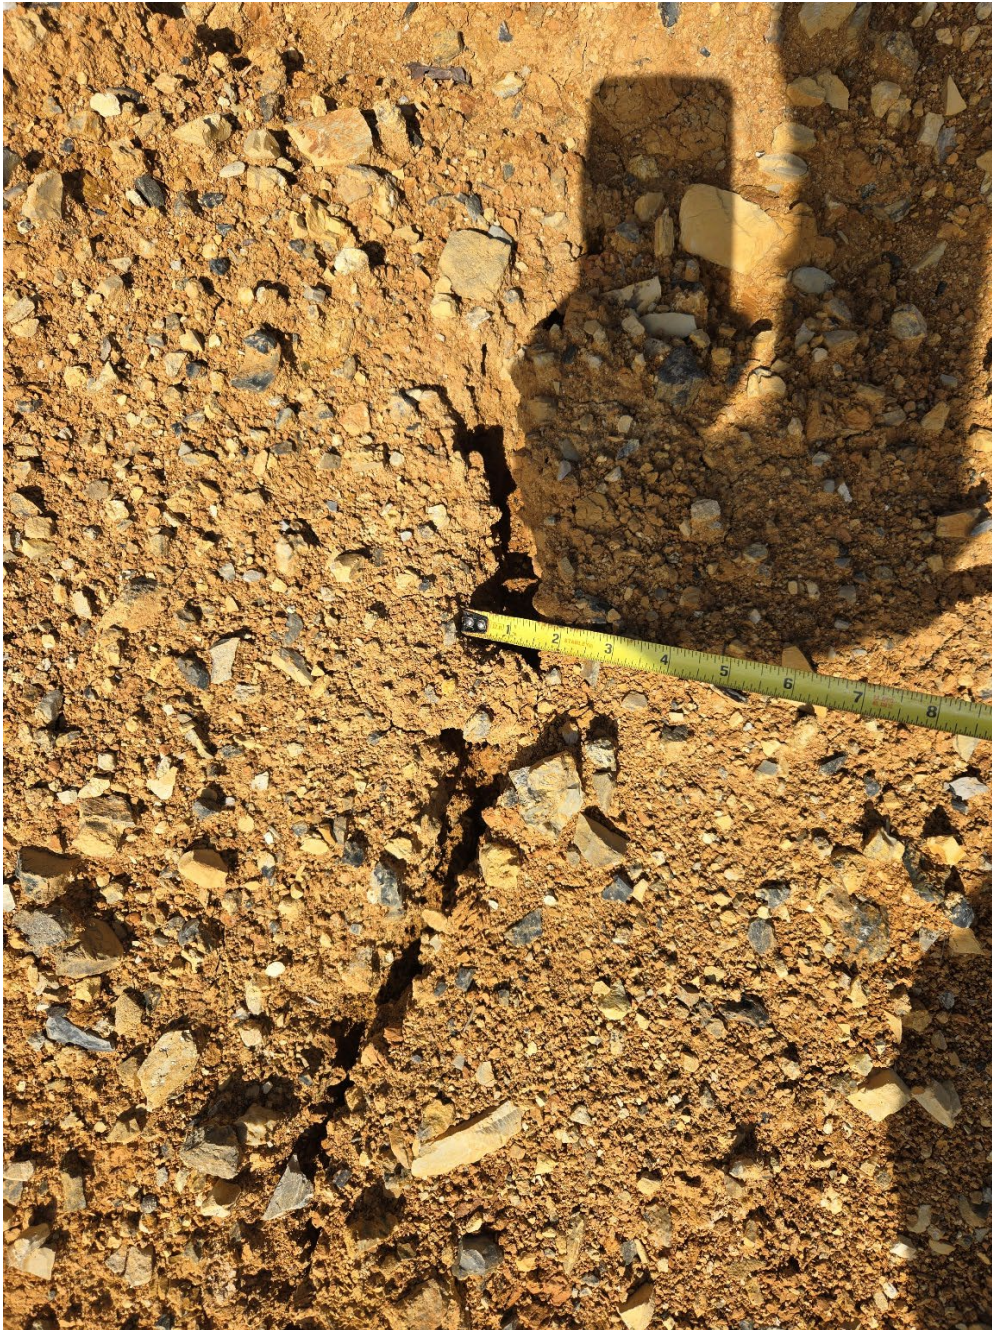
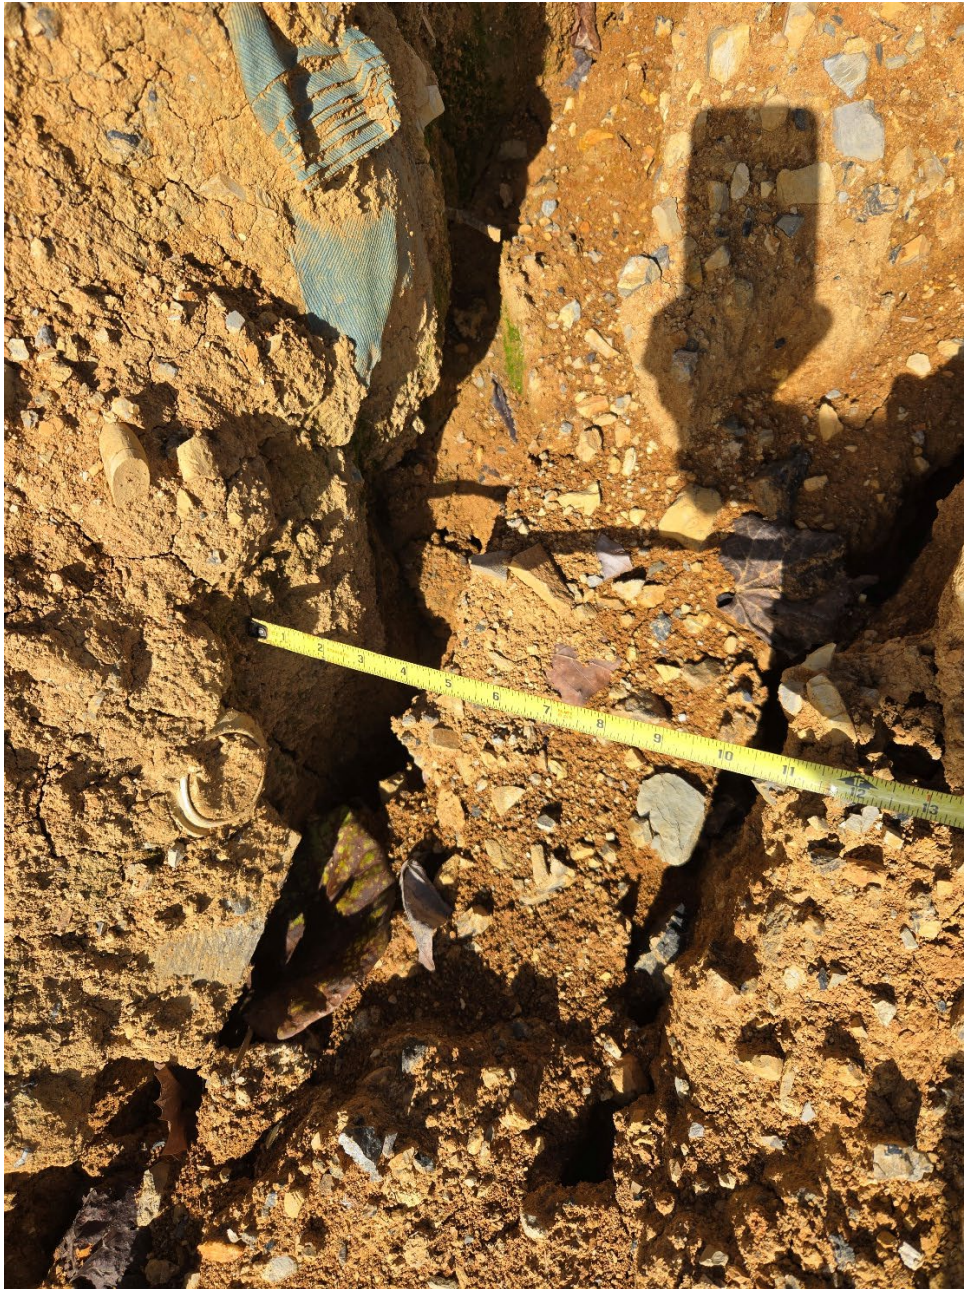
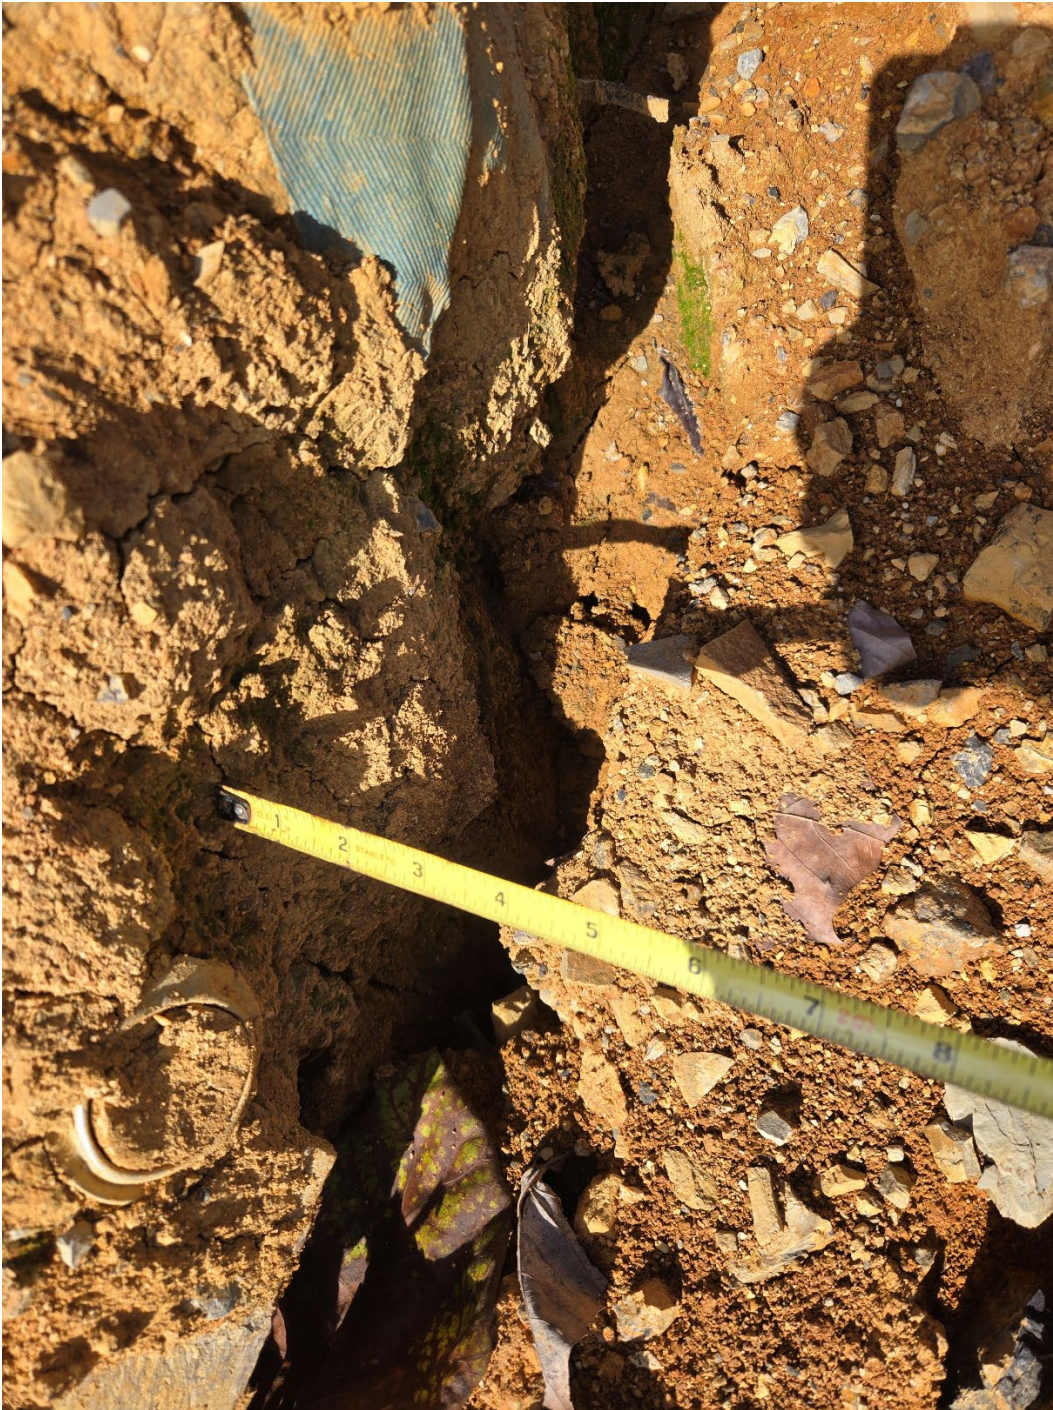
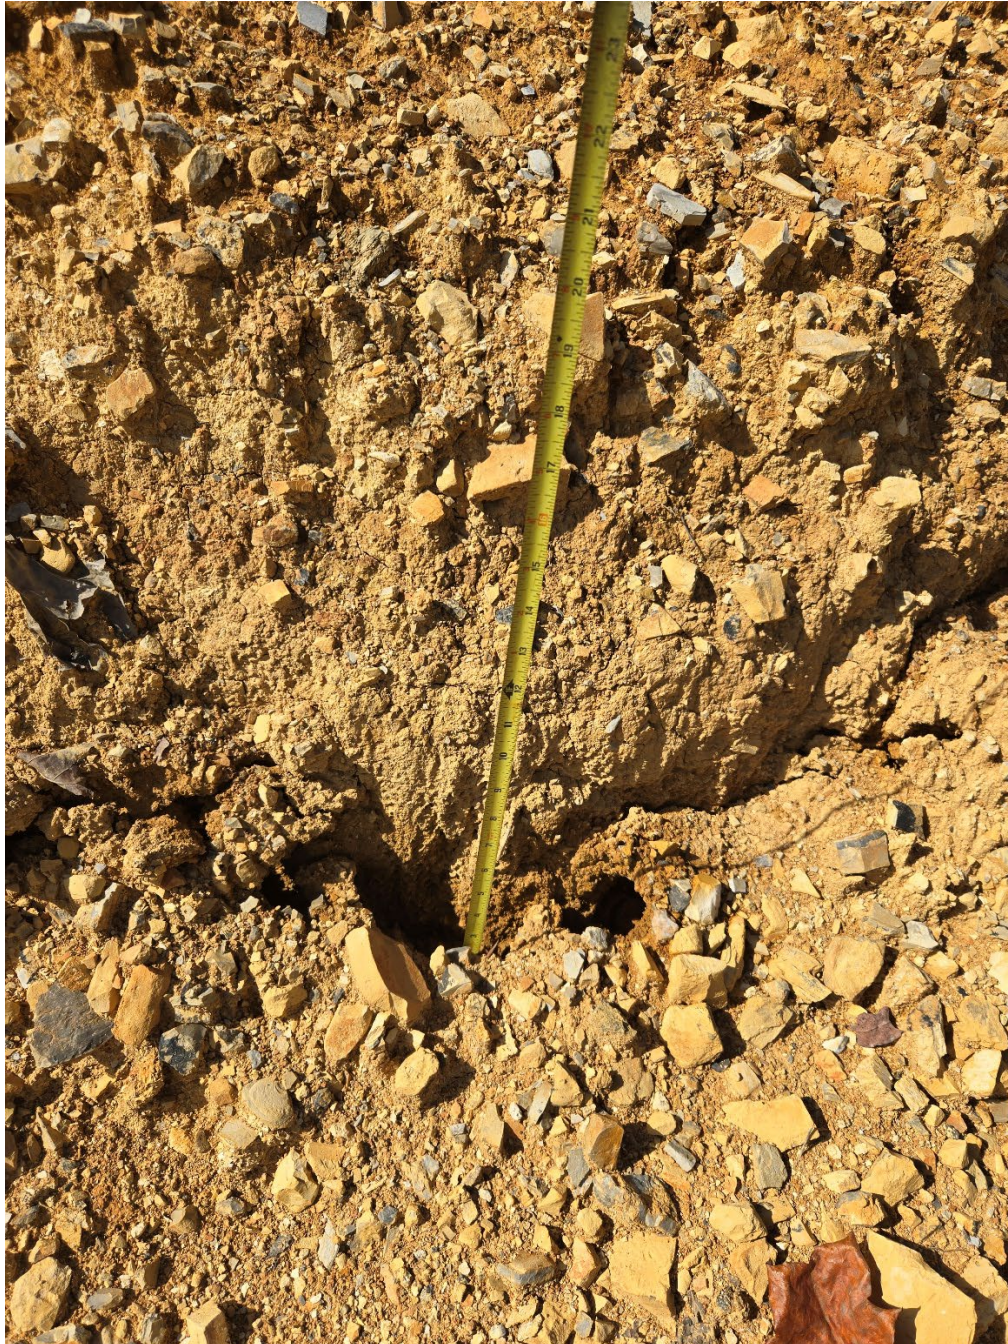
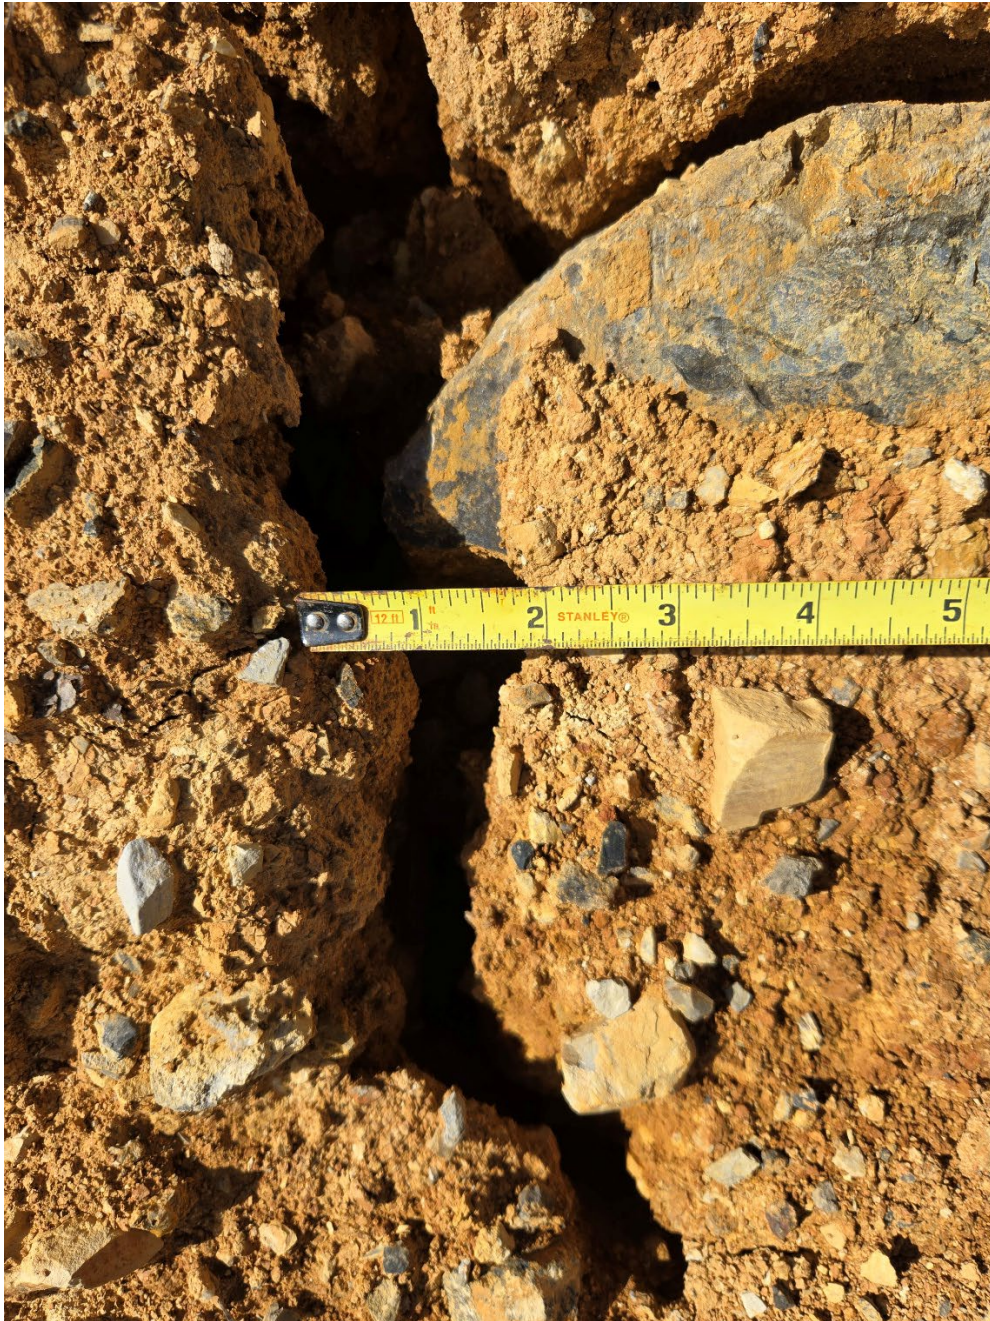
Personnel working in the quarry continue to observe surface cracks due to settlement exceeding 1-inch width. Settlement cracks and depressions were observed during the assessment period, as shown in the photographs below which are from the southwest region of the quarry, near the sidewall riser 3.

Figure 14 – Settlement Crack within the Quarry

Figure 15 – Settlement Crack within the Quarry

Figure 16 – Settlement Crack within the Quarry

Figure 17 – Settlement Crack within the Quarry

Figure 18 – Settlement Crack within the Quarry
