November 2023 Monthly Compliance Report

Solid Waste Permit No. 498
Bristol Integrated Solid Waste Management Facility
2655 Valley Drive
Bristol, VA 24201
(276) 645-7233

SCS ENGINEERS

02218208.05-30 | December 8, 2023

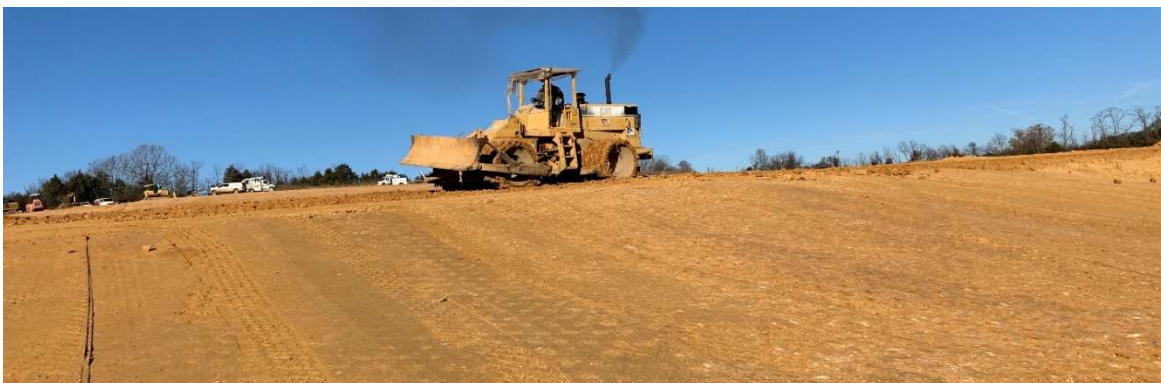
BCS mobilized to the site in late October and construction is currently ongoing. Construction so far has included the installation of erosion and sediment control measures, earthwork to establish the geomembrane deployment grade, and excavation of the expanded stormwater basin. SCS has mobilized CQA personnel to the site to monitor BCS's progress. Grading activities associated with the establishment of geomembrane deployment grades are shown in Figure 1.

Figure 1. Grading Progress on the SWP No. 498 Landfill

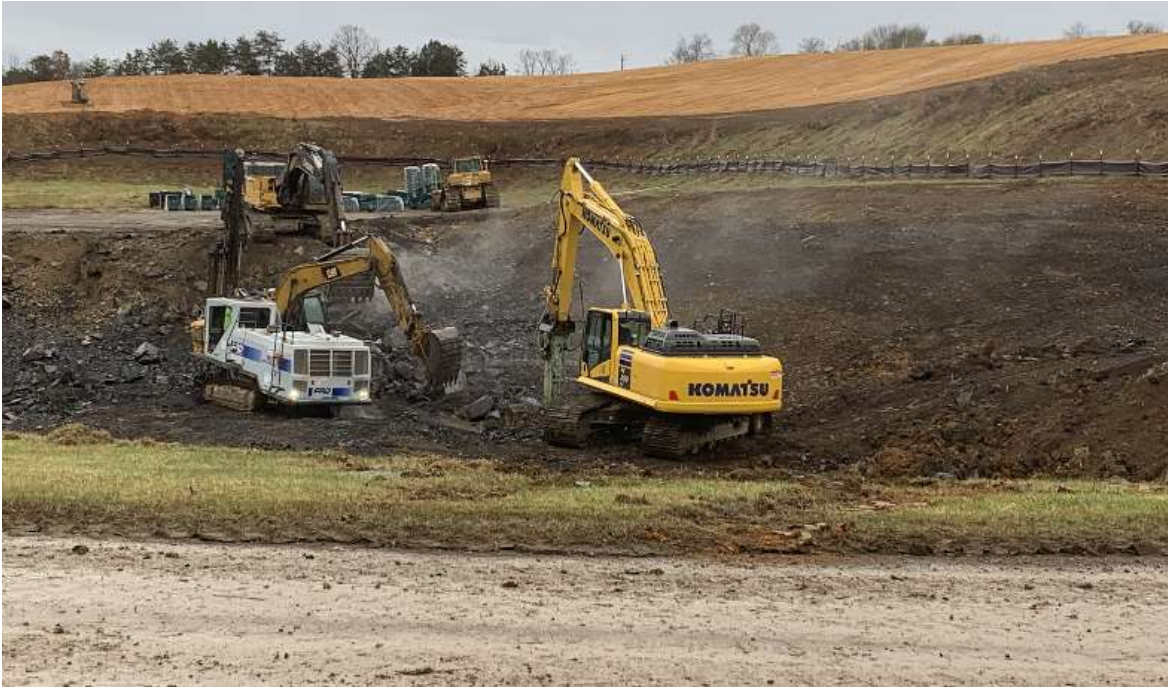
The existing stormwater pond positioned near the northeast corner of the landfill is being expanded to provide additional storage volume, and a new stormwater outlet structure will be installed. The stormwater pond will discharge via the existing 42-in reinforced concrete pipe (outfall SW-1). Stormwater modeling included with the permit modification documents demonstrates compliance with channel and flood protection criteria. The excavation of the expanded stormwater basin is shown in Figure 1.

Figure 2. Excavation of the stormwater basin adjacent to SWP No. 498 Landfill
