January 2024 Monthly Compliance Report

Solid Waste Permit No. 498
Bristol Integrated Solid Waste Management Facility
2655 Valley Drive
Bristol, VA 24201
(276) 645-7233

02218208.05-30 | February 9, 2024

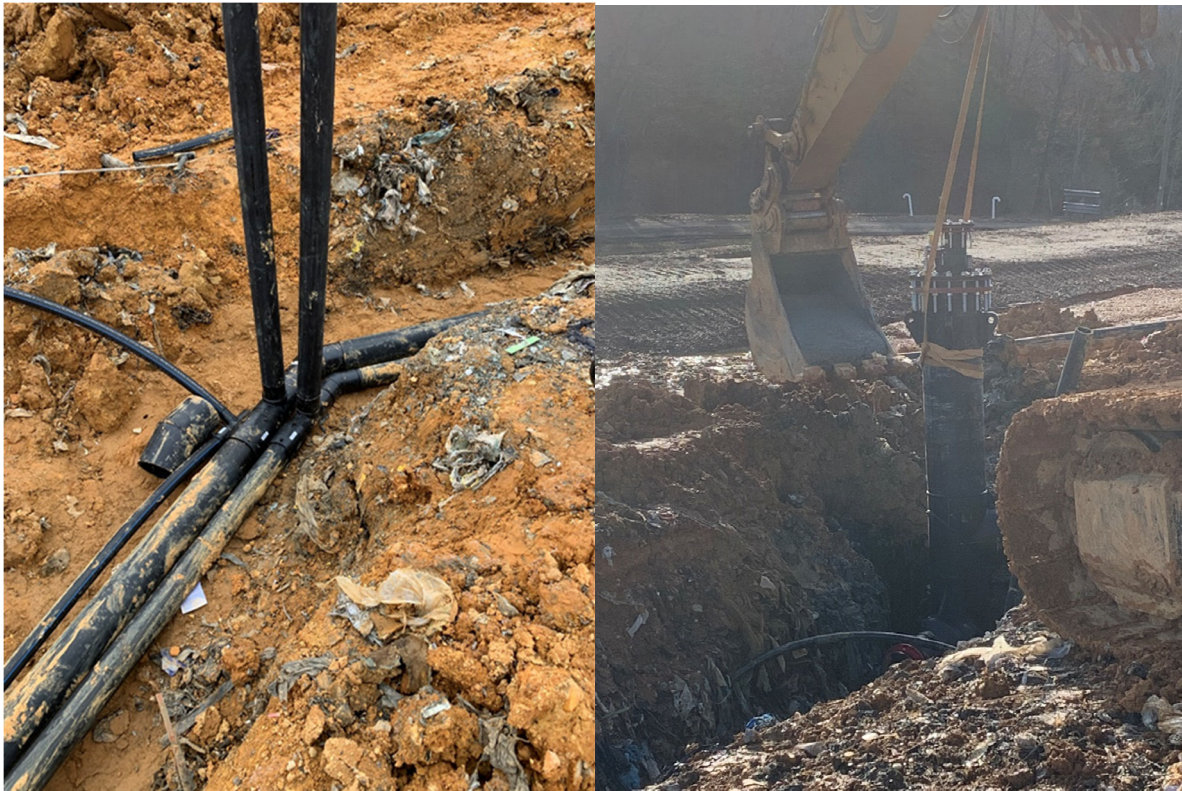
Figure 1. Landfill Gas Installation Progress - SWP No. 498 Landfill

Construction progress during January included installing landfill gas header, airline, and force main. Figure 1 shows electrofusion couplings used to connect the landfill gas pipes (left) and the installation of the new condensate sump (right). Rain and snow accumulation (see Figure 2) resulted in a construction delay between January 12, 2024 and the end of the month. The contractor reported 20 construction days lost due to weather conditions during the month of January.
